FLYROCK INCIDENT IN NSW QUARRY

Posted March 04, 2019 | By Tim Robertson

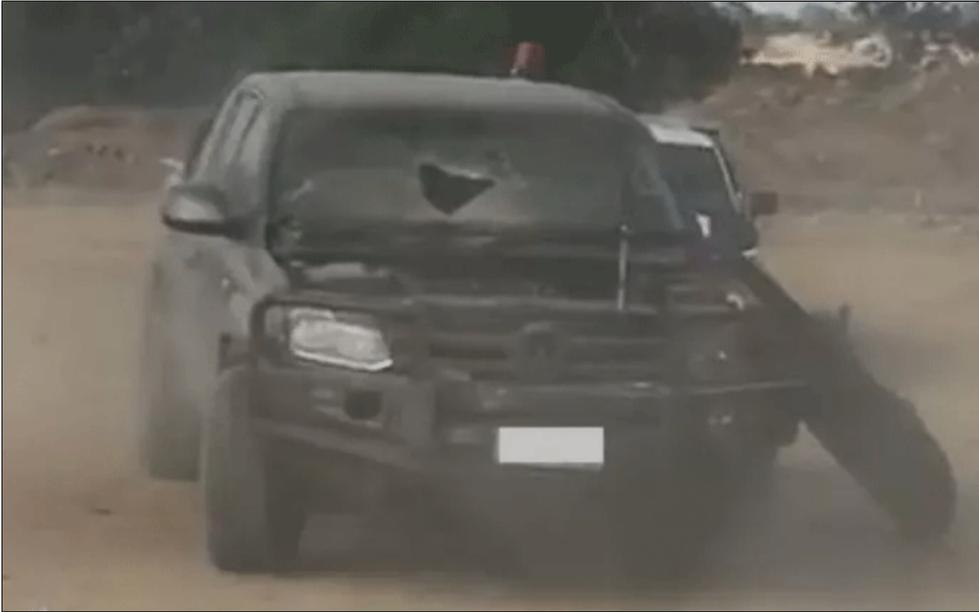
One of three light vehicles damaged by flyrock at Albury Quarry.

"Preliminary enquiries have identified that mine workers and members of the public were between 300 and 340 metres from the blast location. Flyrock from the blast travelled through the air and damaged three light vehicles parked a short distance away from people. Seven people were at risk of being struck by flyrock.

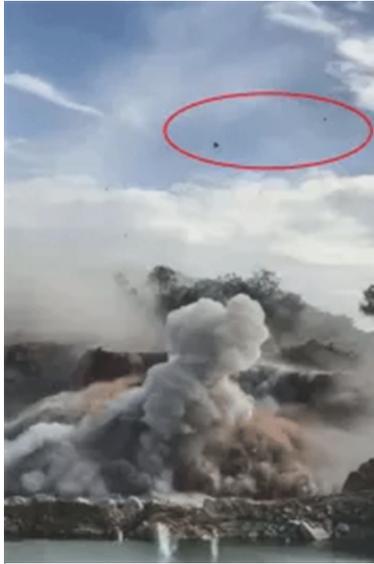
Flyrock circled in video footage provided to the NSW Resources Regulator.
