COAL MINER FACES COURT OVER MINE INTERSECTION CRASH

Date: 13.01.2020

Maximum penalty over failures leading to truck accident put at \$1.5 million

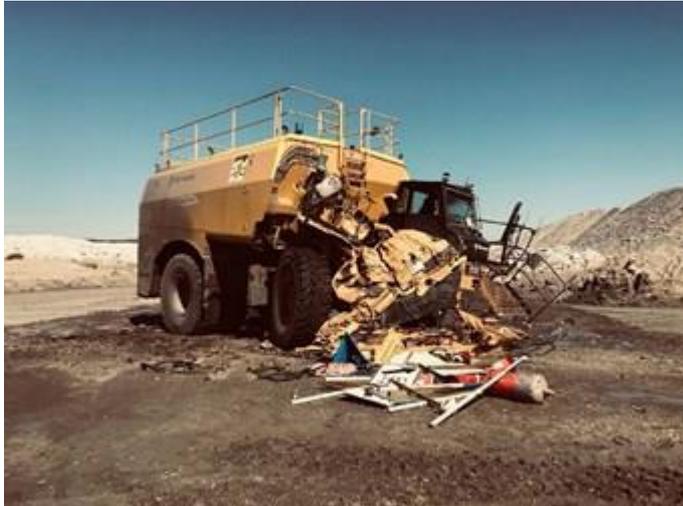
Damage to the service truck after the accident

It finds MCC failed to risk-assess the change to the intersection signs, to consult with workers about the proposed changes, and to clearly communicate the intersection change to all road users.

The service truck driver was unaware that the stop signs at the intersection had been changed the previous day. So, he believed he had the right of way.

The 100-tonne service truck collided with the side of the 500-tonne haul truck, resulting in catastrophic damage to the service truck. The haul truck stopped about 100 metres past the impact point. An emergency response was activated.

Subsequently, MCC improved its pre-start presentation pack to include intersection changes and risk assessment process for intersection changes and implemented a process which requires an engineering review to be conducted when changes to intersections are proposed.

- conduct detailed risk assessments when major changes are made to mine roads
- consult with workers about changes to mine roads
- communicate all road changes to all workers and ensure traffic control signs are adequate, sufficiently visible and appropriately placed
- install appropriate warning signs or barriers to inform road users of changes.
