CRUSHED BY/CAUGHT BETWEEN FATALITY

ALERT 3-21

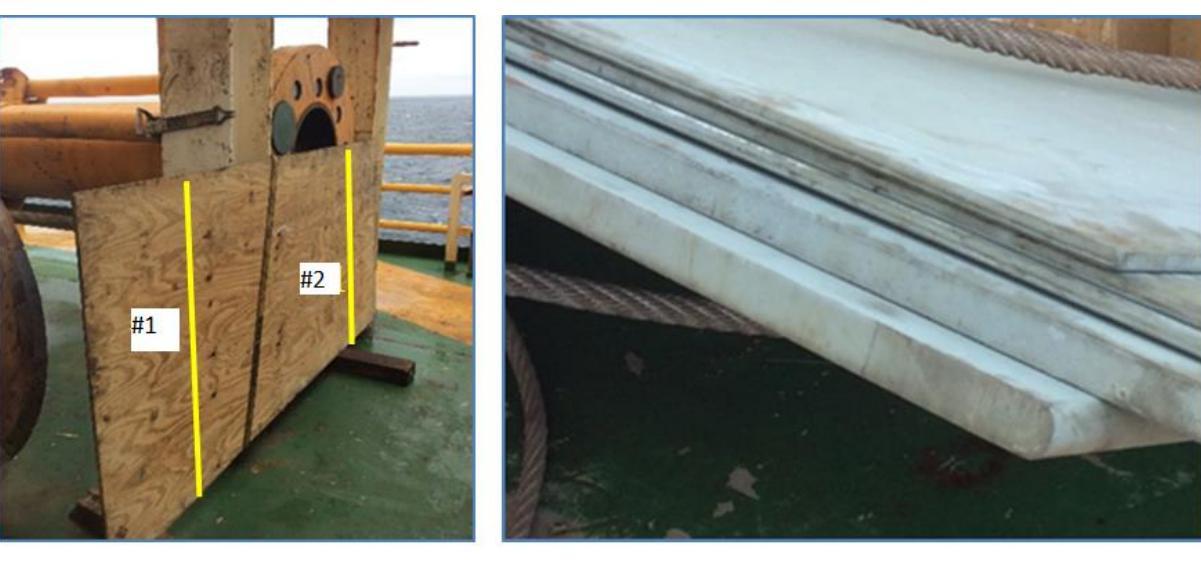
During the inspection, the inspection team leader observed two slings rigged up to a load of 5 metal plates which were stacked vertically, resting on dunnage, and secured to a stanchion by a single 2" ratchet strap (see Figure 1). The slings had been left in place on the plates after they were landed by the crane for efficiency and ease of relocation when needed.

The plates were all 4 x 8 feet; three were 3/8" thickness and the other two were 1" thickness (see Figure 2).

Figure #1: illustration of the position of the plates, using one piece of 4x8 plywood, with the ratchet strap in place and sling position identified

Figure #2: The 5 metal plates, combined weight of approximately 2 T

The inspection team leader attempted to, and was successful in, sliding one of the slings from the plates on the inboard side (#1 represented above in Figure #1), but he discovered the second sling (#2 represented above in Figure #1) was pinched between the rear of the plates and the stanchion, preventing it from being taken off on the outboard side. He then called his assistant and requested that he loosen the ratchet strap, presumably to allow for movement of the plates for the pinched sling to be removed for inspection.

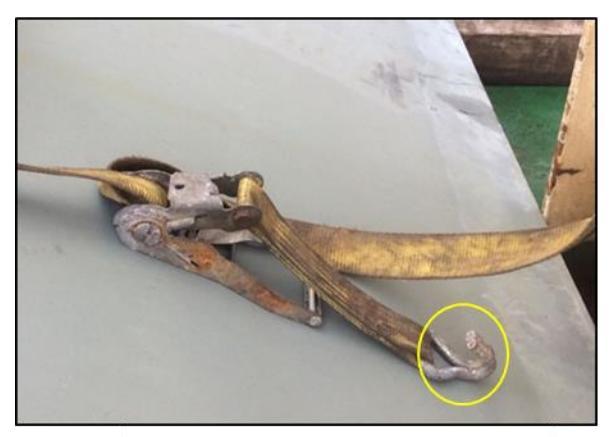
Figure #3: illustration of the ratchet strap hook that came free from the stanchion

- Are there sufficient measures in place to prevent unauthorized manipulation of sea-fastenings? Service provider personnel may not recognize cargo straps as sea fastenings when a rig is in operation. Procedures, including the use of warning tags, should be reviewed to ensure it is clear what needs authorization to release or manipulate

- Review housekeeping and sea-fastening are materials around the rig stored safely and has the potential for gravitational energy to be released been minimized as far as practical (e.g. if a strap comes loose, will the stored material fall or tip over?) Can this be mitigated by storing in an alternative location or an alternative orientation (e.g., by lying flat)?

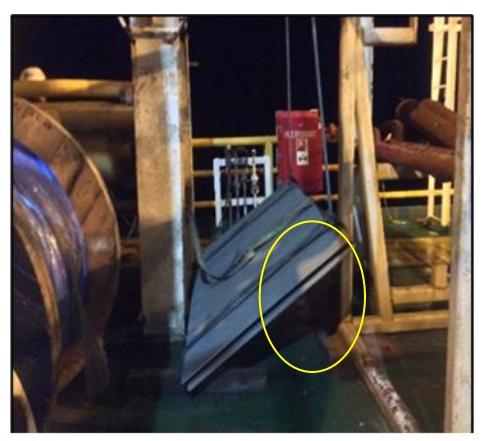
The inspection team leader then leaned his back against the plates; The reason for this is unknown, but it is assumed the intention was to keep the plates in their standing position when the ratchet strap was loosened. When he was standing in this position, directly in front of him was a framework for the drilling bail rack. When the ratchet strap was manipulated by the assistant, the hook (rachet strap) released, (see Figure #3), allowing the plates to free fall forward (away from the stanchion) under their own weight, fatally trapping the inspection team leader between the plates and the framework of the drilling bail rack (see Figure #4).

Figure #4: The position of the inspection team leader

The weight of the falling metal plates, overwhelmed the lead inspector, who was caught in the line of fire and pinned between the plates and the solid frame. First responders arrived at the scene and attempted to manually remove the plates but were unable due to their weight.

- Line of fire awareness reinforce with all personnel the importance of avoiding body positioning in the line of fire, including avoiding getting between loads and structures

- Risk perception and stopping the job are essential to working safely
- Ensure tasks are clear and well planned, including pre-job discussion of factors that would necessitate stop work and reinforce the need to stop and re-assess when the task changes. In this incident, a low-risk task of visually inspecting loose lifting gear changed to a much higher risk task without the team recognizing they were deviating from their task by removing rigged-up slings on sea-fastened cargo, the nature of the task and risk profile changed. It was no longer a low-risk task of visually inspecting loose lifting gear at that point.
