DATE: APRIL 2018

Drill rig worker sustains facial fractures in incident

This safety alert provides safety advice for the NSW mining industry.

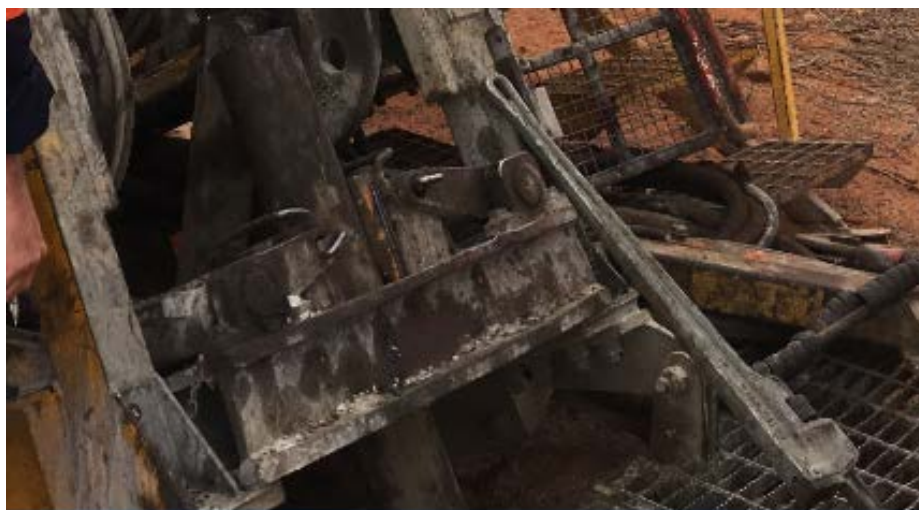
The drill rig operator activated the hydraulic winch to lift the haul plug and rope socket to allow the offsider to attach a short section of drill pipe casing. The shoulder of the pin attaching the haul plug to the rope socket caught on the edge of C-section a foot clamp table, which allowed tension to build up in the winch rope. The force was sufficient to bend the 25 mm frame of the table, chamfer the shoulder off the connecting pin and pull the threaded bolts of the retaining cap from the connecting pin. The connecting pin released from the haul plug and rope socket resulting in the rope socket, haul plug and pin being ejected upward due to the sudden release of the stored energy.

- shoulder of the haul plug connecting pin had caught on the steel C-section of the foot clamp table
- potential hazard of the haul plug and rope socket being caught was not identified
- operator was not aware that the winch rope was under tension
- offsider was standing in an unprotected position
- offsider standing in a position where he was at risk of harm had not been identified
- drill rig operator had 10 years' experience operating drill rigs for other companies and started work three weeks before the incident as an offsider. He was assessed by the site trainer for one day and deemed competent to operate the rig, and was elevated to the main driller due to an operator injuring a finger
- offsider was inexperienced and under the care of the drill rig operator.

Photo 1: Foot clamp table C-section before guarding.

- should assess their drilling rigs to ensure that the potential for an uncontrolled increase of stored energy in the winch rope and all other systems is reduced to as low as reasonably practical
- must develop safe operating procedures based on the outcomes of a risk assessment
- must ensure that only competent trained operators and offsiders are permitted to operate drilling equipment and that they undergo regular scheduled refresher training.

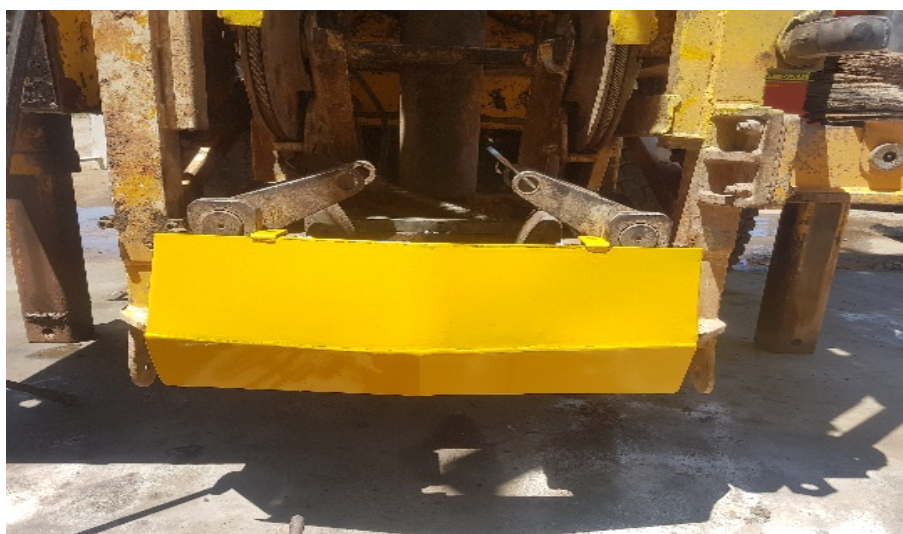
Foot clamp table with guarding fitted
