# NZ Safety Alert

March 2019

## Damaged power cable

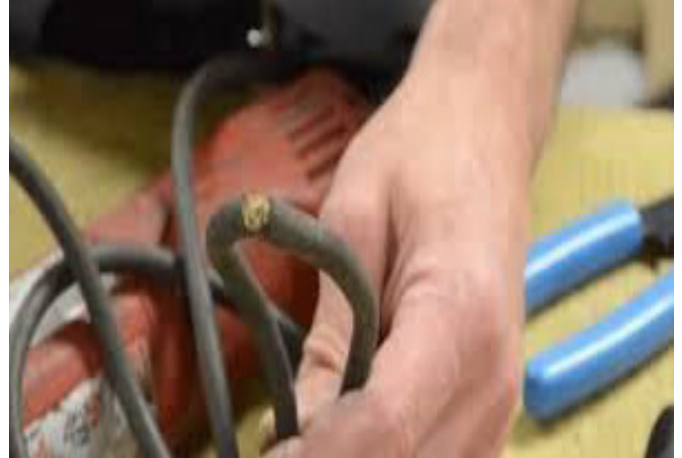
A worker picked up a grinder and plugged it into the power socket. When the grinder wouldn't start the worker inspected the cable to find that there were exposed live electrical wires in the cable. The worker immediately disconnected the cable from the power and cut off the plug so that the grinder could not be used.

The grinder had been previously damaged and put away without being isolated by cutting off the plug.

1. All electrical leads, power tools etc. are visually inspected prior to use to ensure they are fit for purpose.
2. Electrical leads are tested and tagged in accordance with Electrical Safety Regulations and Original Equipment Manufacturer specifications.
3. Equipment with damaged electrical cables are immediately removed from service and isolated to ensure they cannot be used.
4. All activities are adequately supervised, including workplace inspections and task observations.
