## Serious injury

**Event:** Serious injuries at an underground coal mine

**Location:** Springvale Mine, Lidsdale NSW

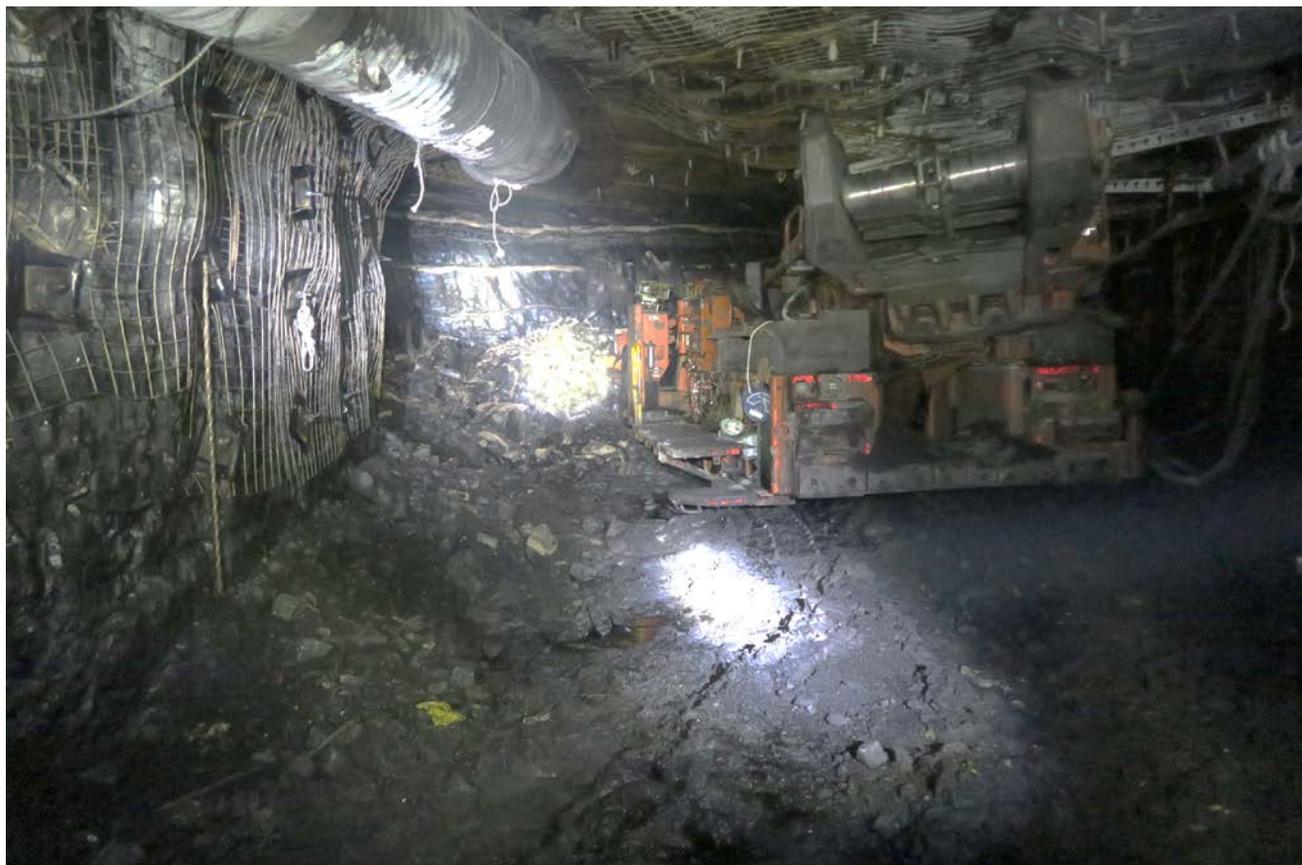
**Photo 1:** Continuous miner in underground heading showing conveyor. Picture by Resources Regulator investigators.

The worker was part of the development team that was breaking away to the left in B-heading of the 426 development panel to mine the seven cut-through to form the gate roads. The worker had pulled the continuous miner back to trim the intersection when the centre conveyor chain jammed.

The worker was standing on the operator platform on the continuous miner and had angled the conveyor in line with his position so he could see down the conveyor chain. The worker reversed the conveyor to free the chain. An object was ejected from the centre conveyor chain of the continuous miner, hitting the worker.

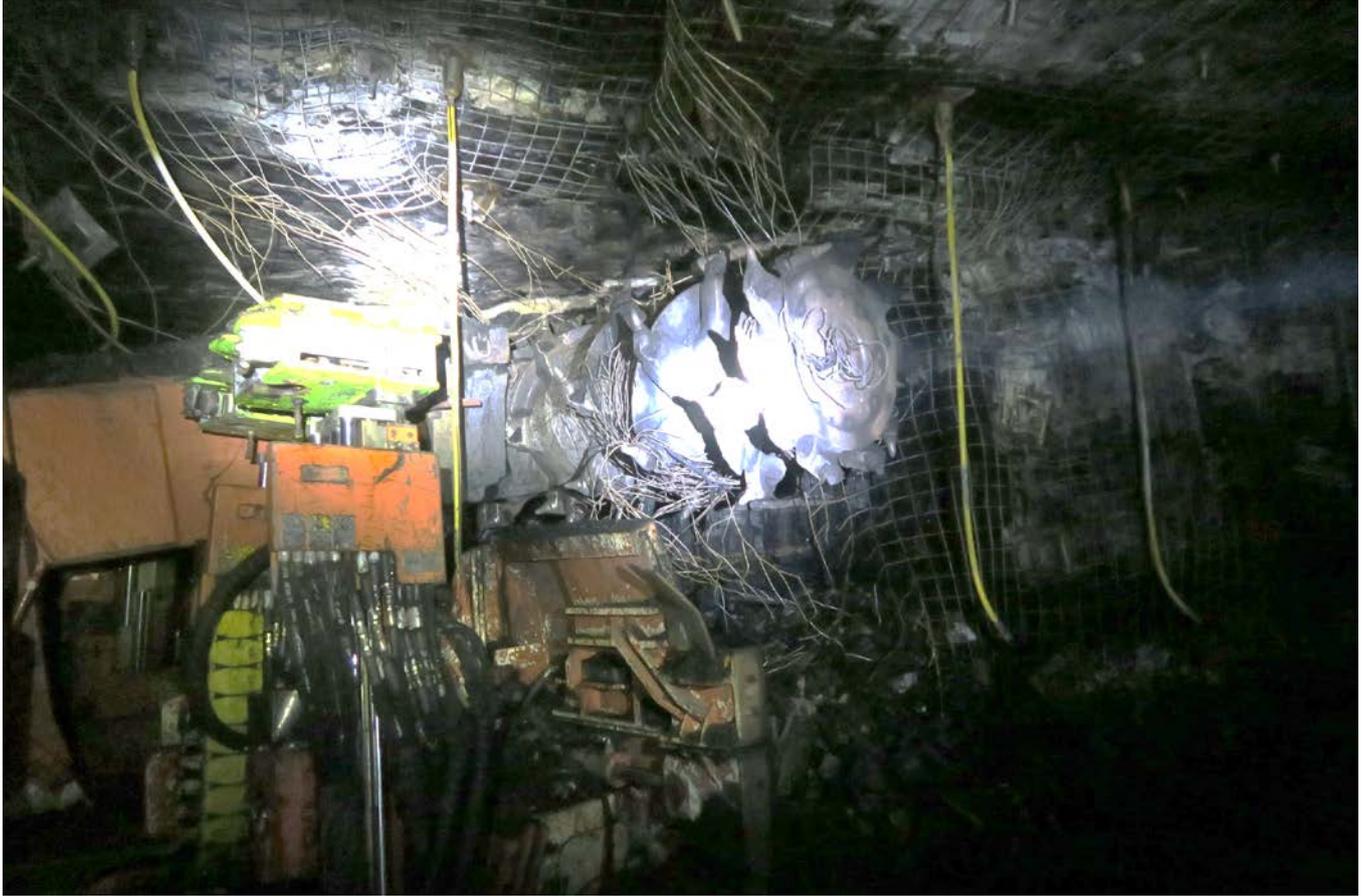
The seven cut-through breakaway was moved 30 metres inbye (closer to the mining face) of the planned position due to adverse strata conditions. The change in breakaway position resulted in the continuous miner cutting through steel rib mesh and steel rib bolts.

Preliminary enquiries indicate that the object that hit the worker may have been the plate from a rib bolt.

Photo 2: Continuous miner showing cutter heads and entangled rib mesh and bolts. Picture by Resources Regulator investigators.

A risk assessment must be conducted whenever a change to the mining sequence, such as pillar size and breakaway distances, is considered. Continuous miners and the steel picks on the cutter heads are not designed to mine through steel strata supports, such as steel rib bolts and rib mesh. Using the continuous miner to cut steel increases the risk of mesh and other materials getting caught around and

entangling the cutter heads and spark generation with potential frictional ignition of flammable materials on the continuous miner and methane gas if it is present in the workings.

Supervisors and workers must recognise hazards and foreseeable risks associated with unblocking conveyors of continuous miners and other plant. Appropriate control measures must be in place before any work is undertaken. There must be sufficient safeguards to prevent a worker being at risk and in the line of fire of objects or component that may be ejected from the cutter head or conveyor chain either while it is operating or under repair.
