SAFETY ALERT

Hand injured by fall of drill rods

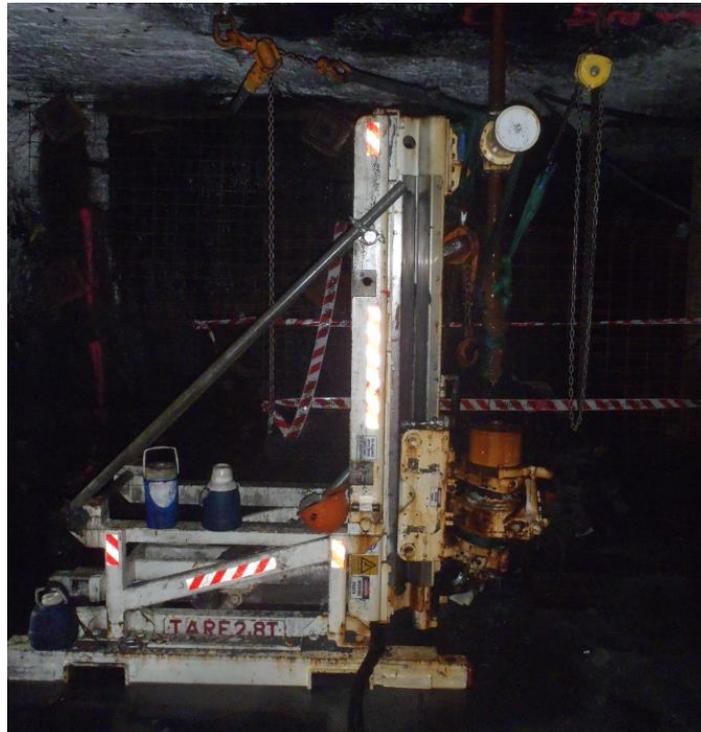
Figure 1: The Radco drill rig that fell on the worker's hand. Photo supplied by the mine.

An investigation into the incident found that while in automatic drilling mode, the drill rig has a safety feature whereby a set of gripper jaws are activated at all times to stop the rig's drill steels from falling out of the roof. The gripper jaws are activated at either the chuck or the top of the drill mast.

The drill rig was still in automatic mode at the time of the incident; however, the operator activated the gripper jaws during installation of the rod causing the gripper jaws to release.

When processes are modified mine operators and mining contractors should undertake a thorough change management process that includes:

- identifying new hazards arising from the change
- assessing any change in risk
- implementing additional controls (if needed)
- training and communicating with any workers affected by the change
- monitoring the effectiveness of controls.
