# NZ Safety Alert

August 2019

## Reports of misfires in NZ increase

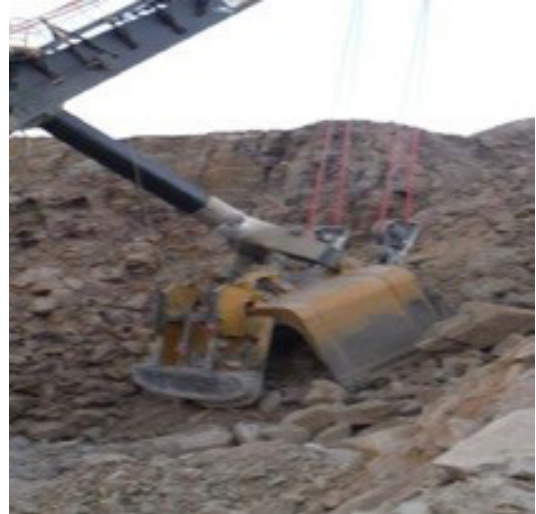
A worker was excavating shot rock in the pit when he found an unexploded booster and detonator in the muckpile. The shotfirer was called to investigate and found a cut downline. While the picture (right) is not the incident referred to, a similar incident caused serious damage to a digger and could have seriously injured the operator.

1. All persons comply with the Health & Safety Management system, security plan, blast controls and standard operating procedures.
2. You review blast design processes, to ensure blast designs take into consideration any geological features or other considerations, which may contribute to misfires.
3. Ensure pre-ignition tie-in inspections are conducted so all tie-ins are checked by at least the shotfirer and one other person.
4. Ensure post-blast inspections are properly conducted to identify areas of potential misfires.
