SAFETY ALERT

Faulty Sabre CABA units

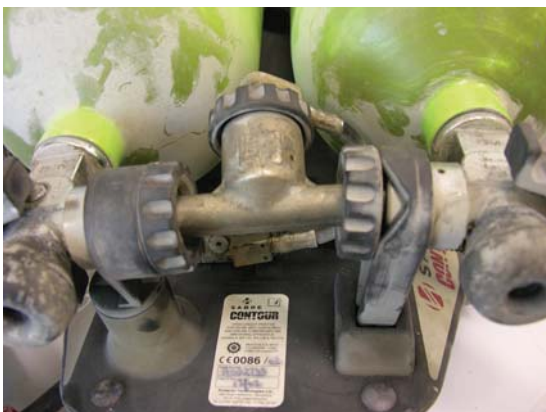
On one unit there was an obvious curve in the T-piece between the two bottles.

CABA unit showing curved connection - should be straight

- All mines should check this type of equipment for faults and contact their suppliers for further information.
- Review handling procedures for CABA units.

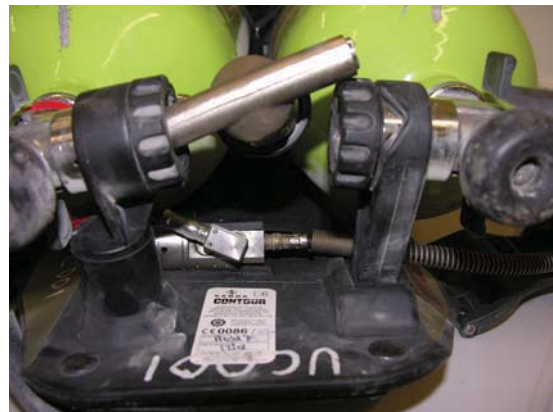
On examination, it was noted that there was flexibility in the T-piece that joins the two compressed air bottles (located near the bottle valves).

CABA unit with T-Piece removed from housing

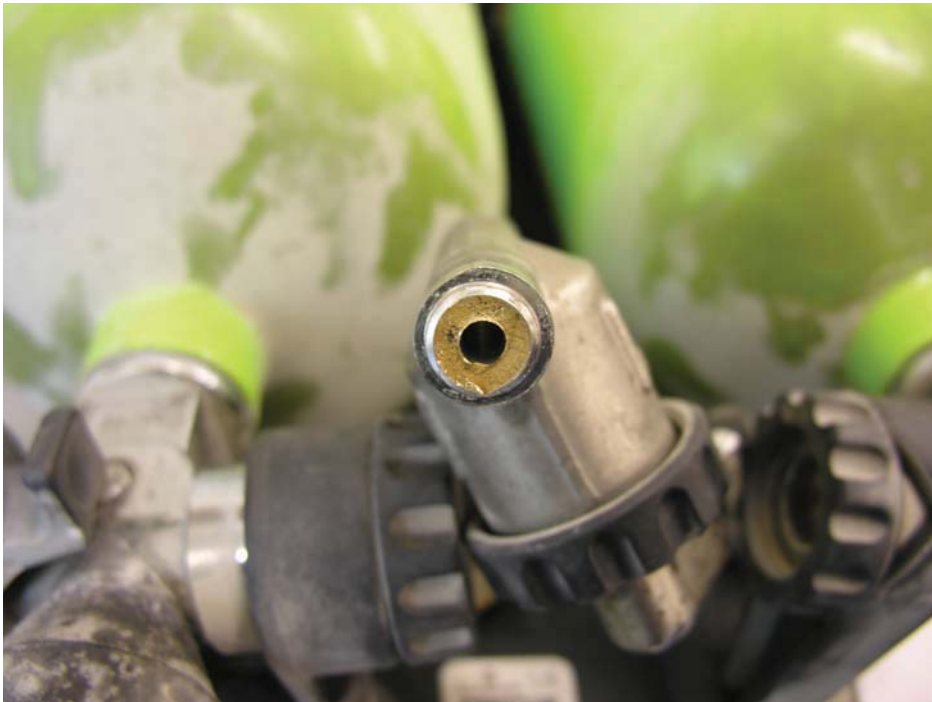
It is possible that the T-piece could be stressed every time the equipment is moved or bumped.

A failed T-piece can be easily detected as there are significant air leaks when the unit is operated.

CABA unit showing broken connection
