Safety Alert

Safety Alert No. 282 | 20 January 2012

Catastrophic structural failure of excavator boom

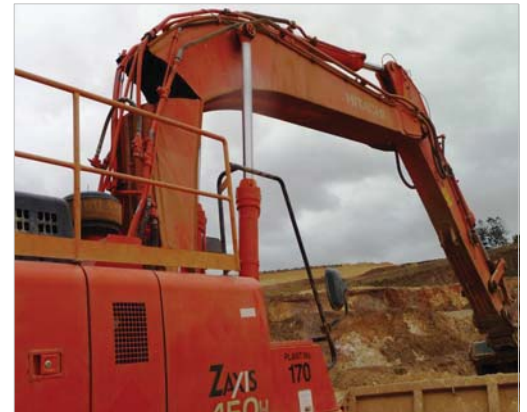
While loading material onto a dump truck, a Hitachi Zaxis 450H Excavator boom fractured, causing the boom to bend along the bottom plate and fall onto the tray of the truck (as pictured).

Undetected cracks had spread at welded joints in a high-stress area of the excavator boom. Points to note are:

- This 2003 excavator had completed nearly 12 000 hours' service.
- On dry hire to the mine, it had been at the site for several weeks, loading mined material into dump trucks. While the mine's cursory pre-acceptance checks had failed to detect cracks or signs of impending failure, rust in the failed area indicated that cracks must have been present for sometime before the excavator arrived on site.
- Maintenance records and service/usage history for the excavator were not available.
- There is some evidence the excavator had been previously used with a hammer attachment.
- Recently, cracks were found near the same area on another Hitachi 450 excavator with about 11 000 hours of service.

1. Site Senior Executives (SSEs) should consult with OEMs to develop and implement periodic maintenance inspection procedures, with an appropriate mix of visual, liquid penetrant and magnetic particle examinations. Account for duty where components may face increased cyclic fatigue, shock loads and vibration (e.g. prolonged use with hammer attachments).

2. Meanwhile, SSEs should arrange regular, thorough visual examinations to detect any cracks or damage and to tag faulty equipment as 'out of service'. Ensure repairs or replacements before operating the equipment again and ensure all inspections, assessments, repairs and replacements are performed by appropriately competent personnel in conjunction with technical advice from the OEM.

3. SSEs should review the process for verifying the condition of used equipment brought to site, including checks on maintenance history, past usage and evidence of inspections conducted on booms, arms and auxiliary equipment.
