# Safety alert

Safety alert no. 259  
15 March 2011

## Injury from a hardened steel sledgehammer

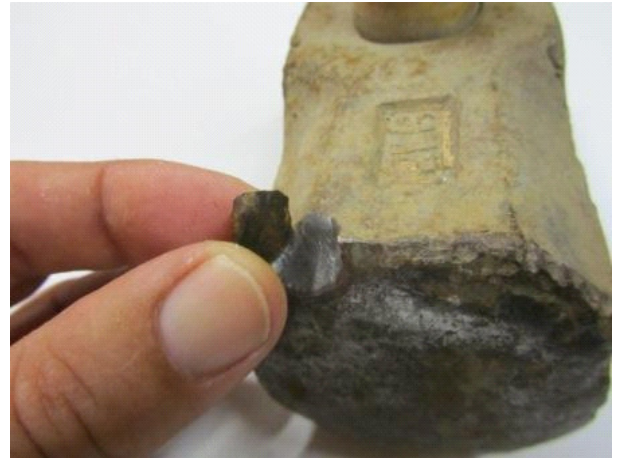
**Incident:** A driller was using a hardened steel sledgehammer to help break out a hardened steel drill rod on a reverse circulation drill rig when a piece of the hammer splintered off and lodged in his shoulder.

**Hazard:** Hardened steel tools used to hit hardened steel parts/objects can shatter or splinter, creating flying shards of steel.

Hardened steel sledgehammer with steel shard

- Lack of knowledge on the hazards of using hardened steel hammers on hardened steel parts;
- Poor communication between maintenance and operations personnel on this hazard;
- Failure to implement an earlier decision to consider alternatives to the sledgehammer for manual handling reasons.

1. Review site procedures and practices to ensure that hardened steel sledgehammers are not used on hardened steel parts and equipment.
2. If a sledgehammer is required, ensure it is made from an alternative material, e.g. a copper faced hammer.
3. Where possible investigate alternatives to using a sledgehammer, for example, when breaking out rods is a C-clamp appropriate?
4. Ensure that mine workers are aware of this hazard.
