## INCIDENT ALERT

LOCATION: QUARRY  
ACTIVITY: MAINTENANCE & HOUSEKEEPING  
SUB ACTIVITY: N/A

ALERT STATUS: Normal  
DATE ISSUED: 17/08/2011  
INCIDENT No: 00297

### Insurance Inspector Near Miss

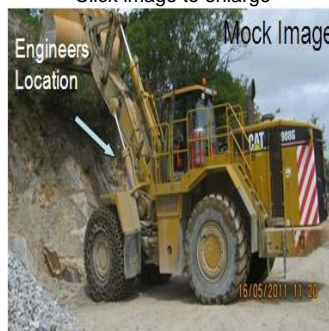
An insurance engineer was undertaking statutory inspections on a number of items of mobile plant at a UK Quarry. During the engineer's inspection of a CAT 998g loading shovel, the engineer was seen to be accessing the front of the Front End Loader (FEL) between the axles beneath a raised boom and bucket.

It was established that the loading shovel was switched off but the driver was still in the cab with the keys in the ignition. The plant operator had dropped the dead man switches to prevent movement of the stick controls, however he confirmed that he did not anticipate the engineer climbing on to the front of the FEL underneath the raised bucket.

When Questioned the FEL operator claims that the engineer could not be seen when he climbed on the front of the loader and eventually off over the wheel arch and front tyre.

- The Risk Assessment (RA) and Safe Working Practice (SWP) provided by the insurance company was not suitable & sufficient.
- The Quarry responsible manager did not effectively review the RA & SWP prior to issuing permission to proceed.
- The insurance engineer did not recognise the potential hazard of crushing / entrapment.
- The FEL operator was not fully briefed on the inspection method.
- The insurance company have a dynamic point of risk assessment tool, but the engineer was not aware of its existence and had not been trained in its use.

Always ensure that all task risk assessments manage all reasonably foreseeable hazards and the controls implemented are suitable and sufficient prior to issuing permission to proceed.
