## INCIDENT ALERT

LOCATION:	QUARRY	ALERT STATUS:	Normal
ACTIVITY:	TRANSPORT / DELIVERY	DATE ISSUED:	19/08/2011
SUB ACTIVITY:	MOBILE PLANT	INCIDENT No:	00304

### The Value Of Well Maintained Safety Devices

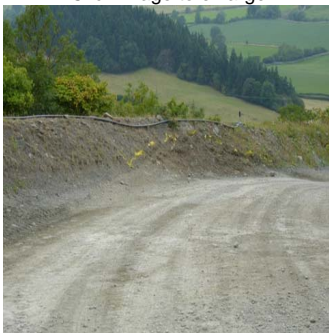
While working on a muckshift operation a contractors dumper lost control while descending a steep section of haul road. The dumper ran up the haul road edge protection bunds a number of times and in each case the bund did exactly what it was designed to do in steering the dumper back on to the haul road.

**Yellow Paint Highlights Outer Wheel Path**

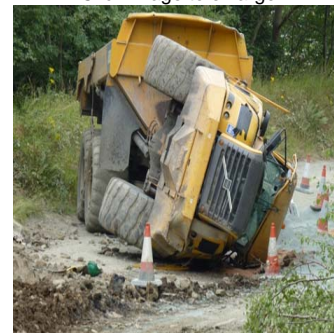
Unfortunately the driver was unable to regain control and the dumper eventually jack knifed causing the front of the dumper to rotate through 270 degrees and the whole vehicle came to rest facing back up the hill down which it had just descended. Despite this the driver freed himself from the vehicle.

**Dumper at Rest**
