## INCIDENT ALERT

LOCATION: **AGGREGATE DREDGER**  
 ACTIVITY: **ACCESS & EGRESS & WORKING AT HEIGHT**  
 SUB ACTIVITY: **N/A**

ALERT STATUS: **Normal**  
 DATE ISSUED: **09/12/2011**  
 INCIDENT No: **00318**

#### Truck Mixer Driver Fall

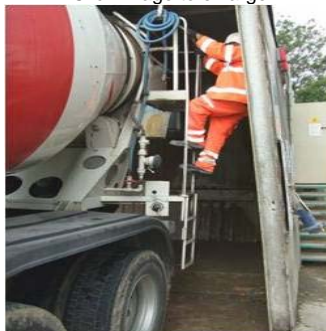
Climbing up to the access platform, the driver coiled away the hose and then started to descend the ladder. During this descent his foot slipped off the 5th rung of the ladder (measured at 1.6m from ground level). As he fell to the ground, he landed heavily on his right foot, chipping a bone in his ankle; not only was he in some pain, being self employed he is now unable to work for several weeks.

Position from where driver fell

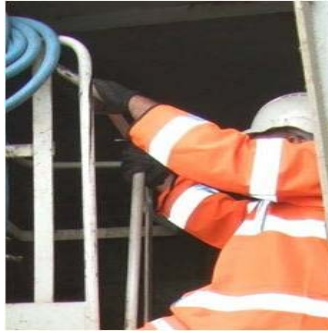
- As he descended the ladder, instead of holding onto both vertical hand rails he used the swing bar as one of his 3 points of contact:
  - Are employees and contractors reminded of the need to GET a GRIP, and maintain three secure points of contact when using ladders and stairways? Is this monitored by site supervision? In this case, the Driver relied on the self closing gate as a point of contact. Have we explained that hinge mechanisms on self closing gates and swing bars should not be used as hand holds? They can easily fail and, as happened in this incident, can cause a person to lose their grip and fall.

**Renactment showing driver holding swingbar**

- The swing bar was bent out of shape causing it to close below its fixing bracket:
  - do we have robust inspection systems in place to ensure this type of defect is identified and corrective action taken?
