INCIDENT ALERT

ROAD TRANSPORT
TRANSPORT / DELIVERY
PRODUCT DELIVERY

Normal
16/01/2012
00322

Vehicle Cab Fire

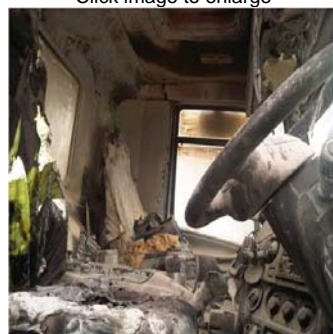
A recent cab fire caused extensive damage to the interior of a truck belonging to a contract haulier. The driver had just got back in his vehicle after loading on one of our sites and was placing his thermos flask behind the driver's seat when he saw a small flame.

There followed a sudden flash of flames and the driver escaped out of the drivers door. It took 4 full size fire extinguishers to put the fire out. The driver suffered minor burns to his ear whilst escaping from the cab – although he was wearing his safety helmet at the time which protected his head from the flames.

On investigation it was found that the terminals for operating his tipping gear were exposed and that some cleaning material aerosols which he stored behind his seat had come into contact with the exposed terminals and an arc of electricity had pierced one of the aerosols and caused the explosive reaction.

Burnt Out Cab

The cleaning substance was stored loosely behind the driver's seat – Do you have a safe, secure place to store all tools, equipment and substances? Do you carry out housekeeping audits on vehicles?

The tipping equipment terminals were not correctly covered (isolated)? – Is all equipment inspected on a regular basis and contained appropriately?

The aerosol exploded because it was flammable – are all substances hazardous to health assessed and control measures in place to ensure safe use and storage?

The driver was unaware of the risk of storing aerosols behind his seat – are all employees trained in the safe use and storage of substances under COSHH?

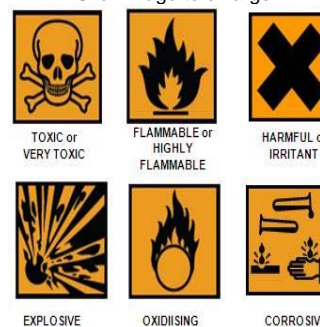
Simple products, such as furniture polish, can be classed as hazardous to health and the packing will display one of the symbols above. The aerosol which exploded was silicon based dashboard cleaner. Anything with a warning label should be considered under COSHH assessments and suitable controls in their use and storage implemented.

Symbols
