NZ Safety Alert

Sledgehammer injures worker

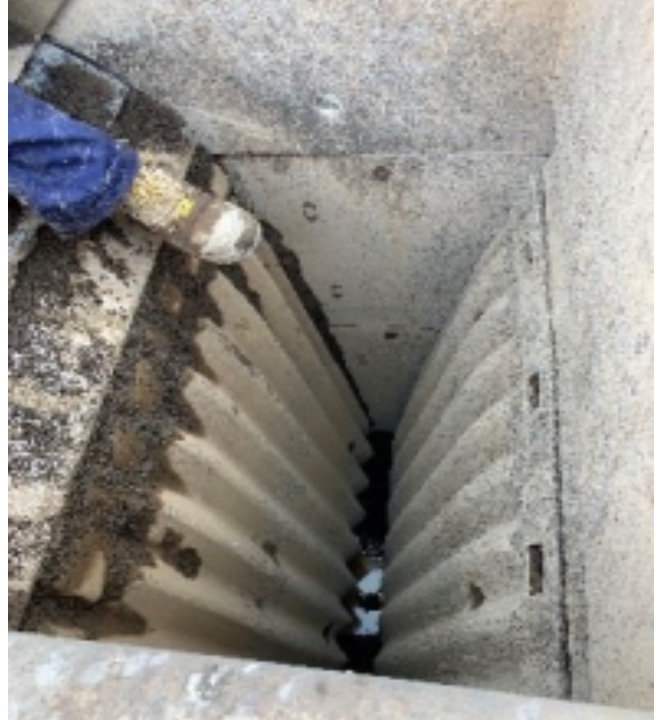
Workers were changing jaw liners on a Jaw Crusher. One worker was attempting to tighten bolts used to fasten the liner to the crusher by using a sledgehammer. He was holding the hammer handle very low down, as he attempted to swing the hammer upwards to hit the bolts.

He was working in a confined space within the isolated jaw and as he reached up, he did not have enough space to complete the entire movement and the handle of the sledgehammer swung into his lower back directly behind his ribs.

The worker noticed slight discomfort but completed the task. Over coming days, he experienced increased pain and was diagnosed with a chest wall contusion requiring pain killers and time off work.

1. Appropriate tools are used for all tasks. Torque wrenches and hydraulic tools should be considered to replace hammers and striker plates.
2. You review access to plant for maintenance including isolation, weather conditions, confined space, limited access etc.
3. Workplace inspections include behaviour and task identification to ensure tasks are carried out safely.
