Lessons Learnt

Category	Safety & Health <input checked="" type="checkbox"/> Environment <input type="checkbox"/> Quality <input type="checkbox"/> Sustainability <input type="checkbox"/>
Business Unit	Tunneling & Major Projects
Project	WestConnex M4E
ID + Version	LL-<WCX M4E>-<T80020.W10.SAF.080118.00118058>-<Version No.1>
Date Developed	19/05/2020

25t Terex Articulated Mobile Crane Rollover

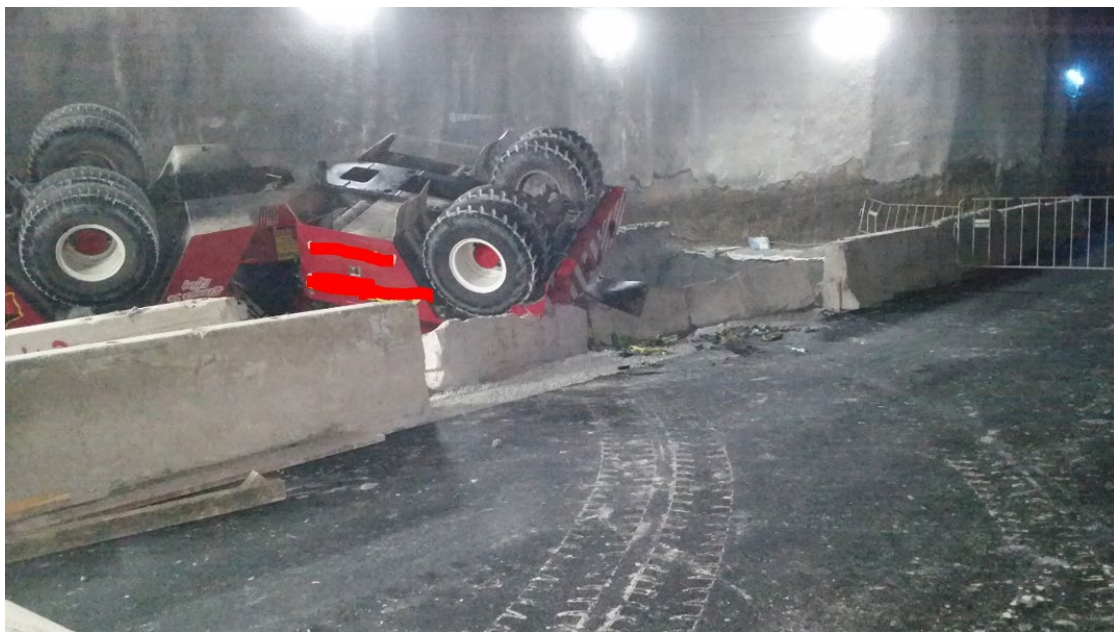
Photo: 25t Terex articulated mobile crane rolled over onto the roof and edge of the shaft. Tyre mud marks on the asphalt indicate the crane location prior to incident.

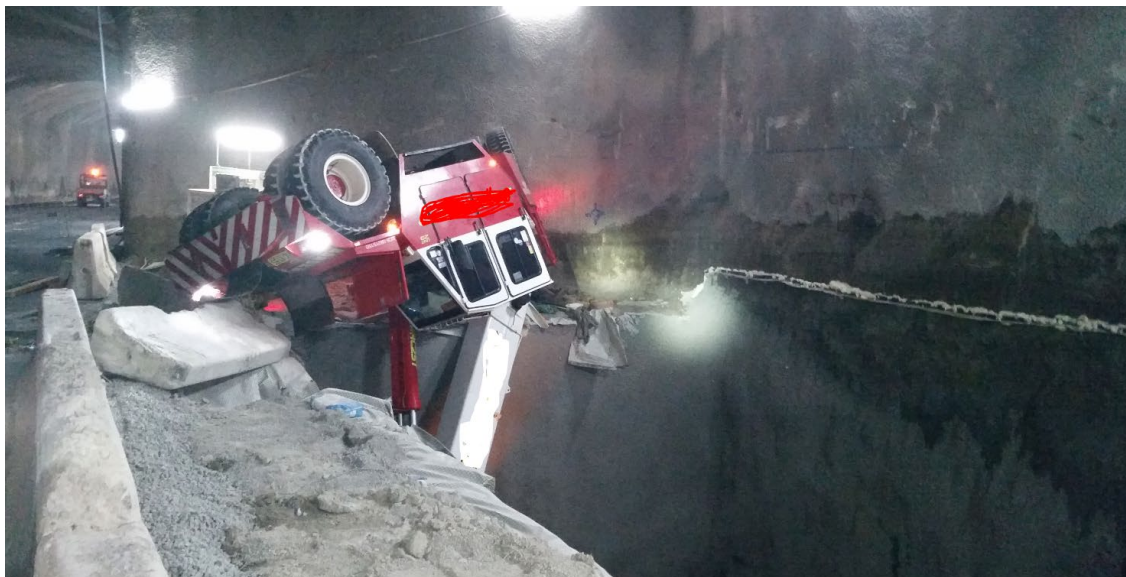
Photo: 25t Terex articulated mobile crane on the edge of 10m deep shaft

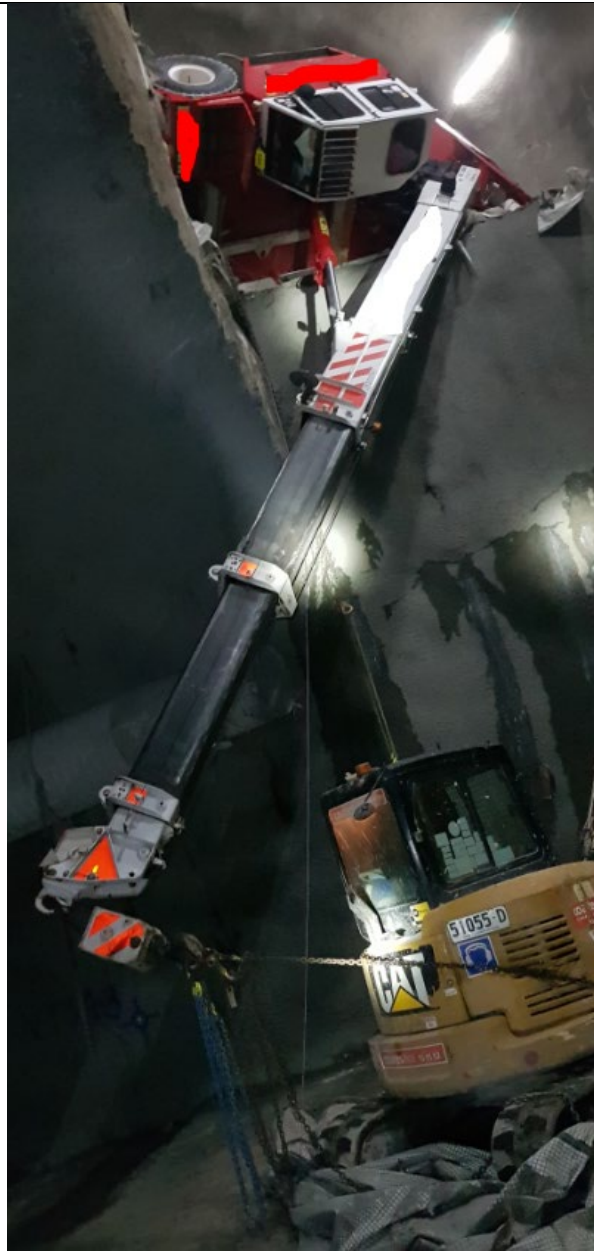
Photo: From the base of the 10m deep shaft, looking up to the 25t Terex articulated mobile crane
