WEEKLY INCIDENT SUMMARY

Week ending Friday 17 July 2020

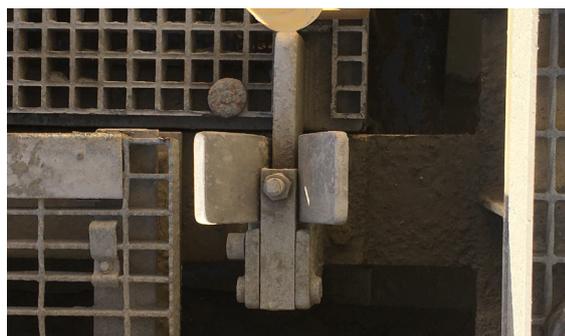
INCIDENT TYPE	SUMMARY	COMMENTS TO INDUSTRY
Dangerous incident IncNot0037768 Open cut metalliferous mine	A plant operator was installing an interstage screen using a gantry crane. During the lowering process, the operator noticed that a locking pin was in the closed position, causing an obstruction. As the operator opened the locking pin, the screen (load) moved and crushed the operator's finger between the screen body and the locking pin.	Mine operators and PCBUs should review their procedures and training packages to ensure they include the potential hazards associated with placing body parts on solid objects around moving parts and material.

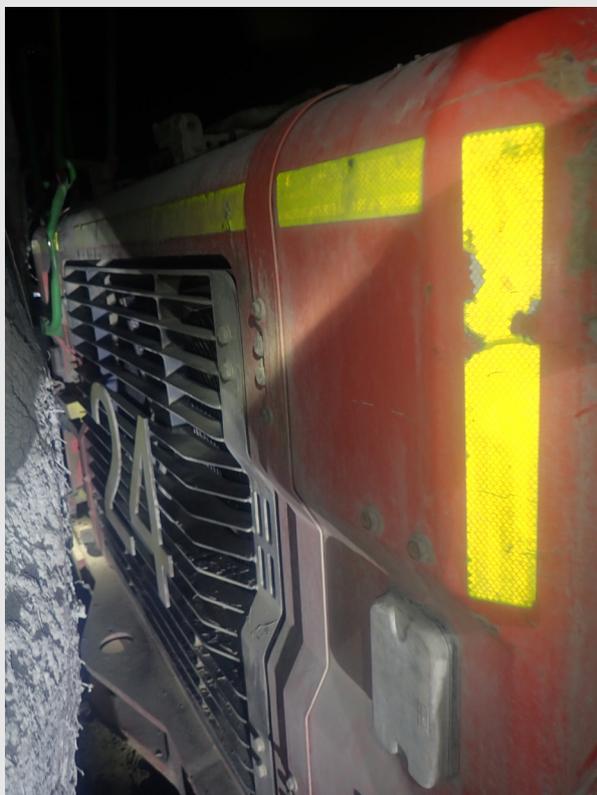
Dangerous
incident
IncNot0037752
Underground
metalliferous
mine

While tramping down a decline, a truck's brakes failed. The truck bounced off the left and right-hand walls before the operator turned it into the wall to stop it.

The operator had conducted a pre-start check and the brakes were confirmed to be working.

This incident is under investigation and the reason for the brake failure was unknown at the time of publication.

Mines are reminded of the requirement to have thorough lifecycle management plans for all equipment, including operation and maintenance procedures.

When work is carried out on a safety-critical system, appropriate work verification procedures must be in place.

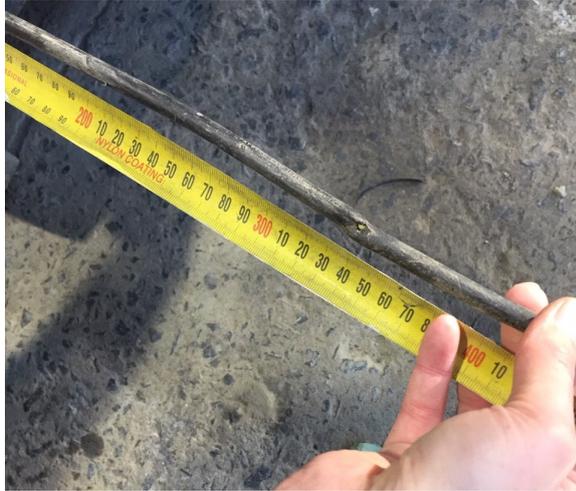
Dangerous
incident
IncNot0037742
Quarry

A worker was about to use a 240 volt pressure washer when he suffered an electric shock. An examination of the pressure washer revealed a damaged power cord.

Mine operators must have systems and checks in place for workers to carry out pre-use inspections of portable electrical equipment and monitor worker compliance.

Workers must inspect equipment before operating it to ensure it is fit-for-purpose and free from damage. Power leads should be

fully unwound and checked for damage before being plugged in.

Damaged equipment should be reported and managed in accordance with the mine’s defect management system.
