Worker trapped in machinery

19 February 2020

Incident overview

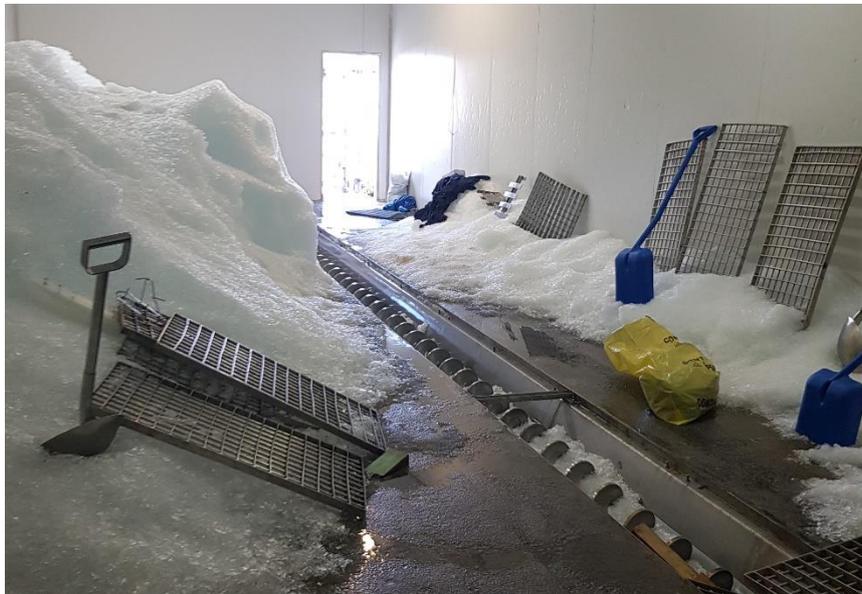
A 34-year-old worker was shovelling ice into a horizontal screw auger conveyor at a poultry processing plant at Tahmoor when his leg became trapped.

Machine that trapped the worker

Make sure you separate workers from moving machinery by having:

- **permanently fixed guarding**, where access is **not required** during operation
- **interlocked guarding**, where access **is required** during operation

If these options are not practicable, make sure the guarding can only be removed by using a tool.

- is solid and securely mounted
- is difficult to by-pass or disable, whether deliberately or accidentally
- can be removed for maintenance and cleaning tasks – but the machine can't be restarted until the guarding is replaced
- doesn't create a new hazard
- doesn't make the machine more difficult to operate, which may result in the guard being removed or disabled
