NZ Safety Alert

September 2019

Crowbar severs electrical cable

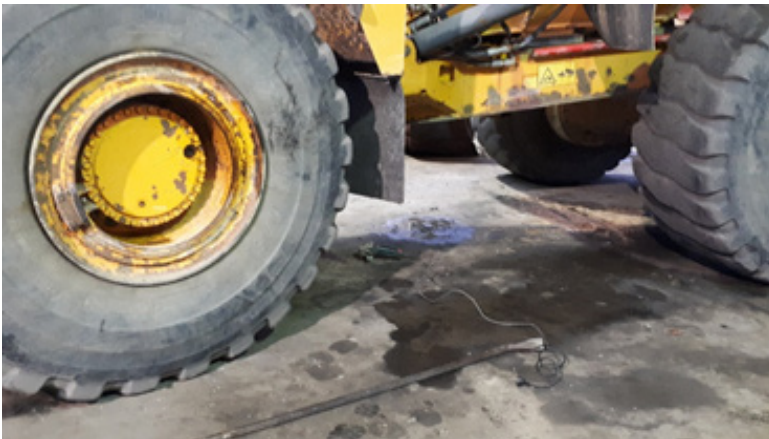
A crowbar was left leaning upright against a light vehicle in the workshop when workers left for smoko. The crowbar fell severing an electrical extension cable on the floor of the workshop.

An RCD activated and automatically shut off power to the extension cable.

1. All items of plant, including tools and leads etc. are fundamentally stable while being used or not. This means placing tools where they cannot fall, disconnecting power leads and rolling away leads and hoses, and putting tools away in storage racks when not being used.
2. Regular workplace inspections are conducted to identify housekeeping issues and set-up of work areas that could put workers at risk of harm.
3. Operators are trained and assessed as competent to operate plant and equipment, including insuring it is fundamentally stable.
4. Lessons from incidents, including learnings, are shared with all workers
