# SAFETY ALERT

**DATE: JANUARY 2021**

## Elevated work box falls from integrated tool carrier

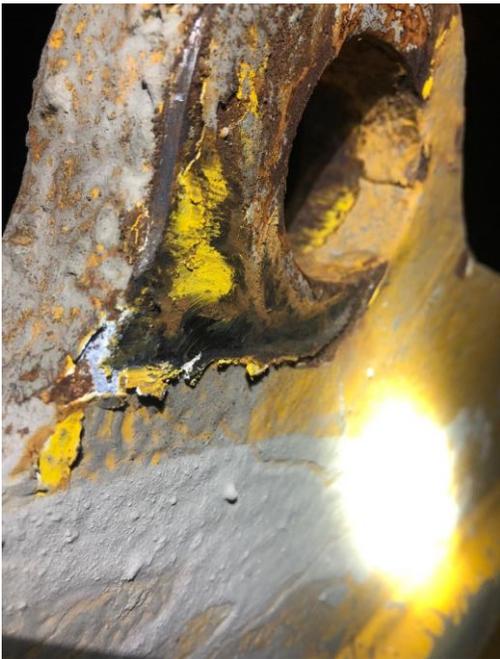
*Figure 4. Gouge marks on face of workbox locking pin receptacle*

- Control measures employed to ensure the effective and secure coupling of work boxes and implements to mobile machinery are reviewed, taking into account the hierarchy of risk controls.
- Operational switches in mobile equipment are of an appropriate type, positioned and labelled appropriately to prevent inadvertent operation and consideration is made to install additional barriers or protection of the locking pin release switch.
- Each worker verifies the effectiveness of a control measure prior to placing their isolation lock and tag.
- Information, instruction and training are provided to, and implemented by workers for the safe use of workboxes.
