NZ Safety Alert

January 2020

Excavator falls on its side

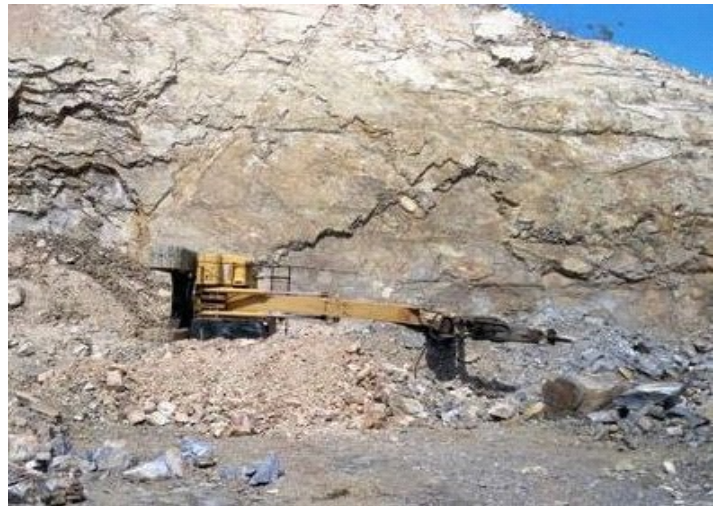
An excavator was working on a pad approximately 1 metre high sorting material.

The excavator tracks reached the end of the working bench when the left excavator track either moved onto soft material and/or the end of the track extending beyond the edge of the pad.

As the excavator slewed approximately 100 degrees anti clockwise with boom extended, the excavator became unbalanced and rolled onto the left-hand side of the machine.

The operator was injured. Drug and alcohol testing proved negative.

1. Working pads are adequately compacted and constructed such that they are at least 1 ½ times the area of the excavator tracks.
2. When working on benches, excavator tracks be parallel to the face and positioned an adequate distance from the edge considering; the stability of the edge in terms of geological structure, blast damage and undercutting.
3. That operators understand Original Equipment Manufacturer operating instructions including; load limits at various boom extension distances, stability parameters, and safe operating procedures.
4. Excavators are fit for the intended purpose (i.e. appropriate machine specifications in terms of size, working load and reach).
