# NZ Safety Alert

## Fall of axle assembly

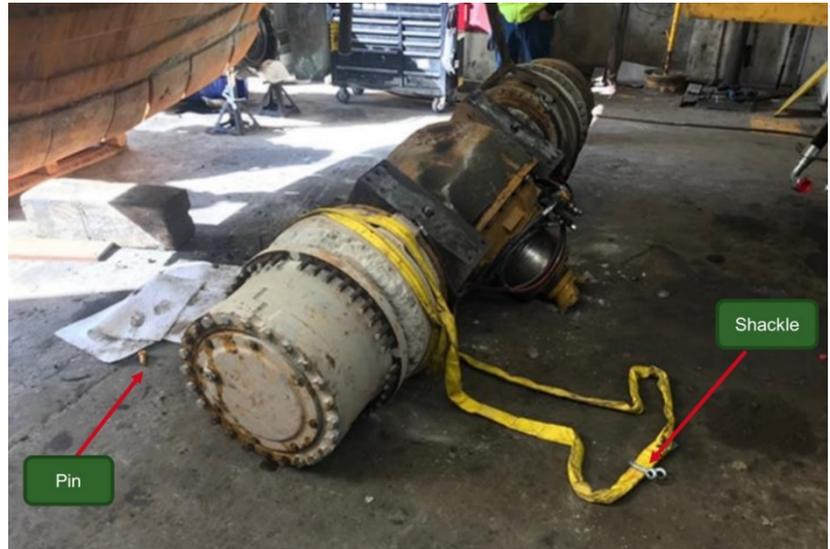
Two fitters were fitting a 3-tonne front axle assembly onto a loader. A spreader bar was used to allow the correct placement of the two slings on each end of the axle. Each sling was attached to the spreader bar via a 3.2 tonne rated bow shackle.

To centre the axle under the bucket lift arms, the load was picked up and put down multiple times as it was manoeuvred into place. Each time the load was put down the bow shackle on the western end (closest to camera in picture) was undone so the sling could be re-run past each of the loader lift arms before being attached to the spreader bar with the bow shackle again.

Once centred, the axle was being lifted off the cribbage when the west side sling dropped, the spreader bar flung around and landed on top of the loader bucket, and the axle dropped onto the cribbing and then slid off onto the floor.

1. Where practical, other devices (e.g. skates etc) for moving axles into place are used that do not require the use of repeated lifts.
2. Review lifting processes and where possible replace bow shackles with safety hooks.
3. When lifting ensure that no-one is in the fall zone of the item being lifted.
4. All workers are trained and regularly assessed as competent in safe lifting procedures.
5. You regularly inspect all equipment used for lifting.
