Mines Safety Bulletin No. 177

Subject: Installation and maintenance of temporary generators

Date: 10 August 2020

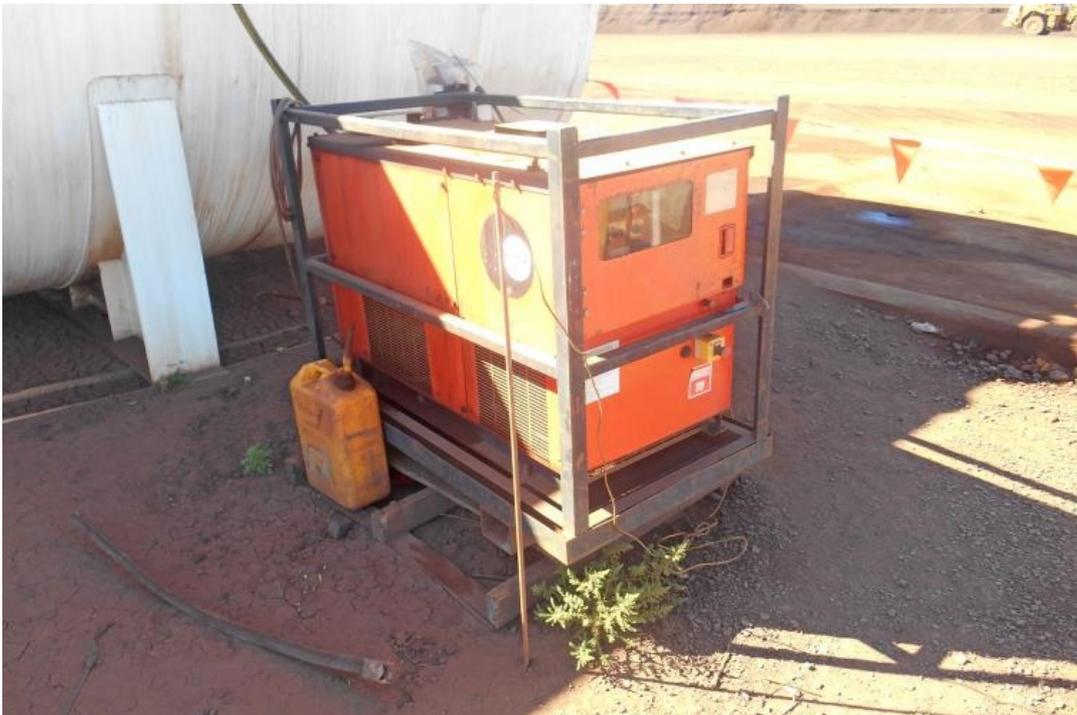
Poor housekeeping standard at a temporary generator installation.

- In all generator installations, equipment must be installed in accordance with AS/NZS 3000 and AS/NZS 3010. Cables must be appropriately rated for the expected operating conditions, fixed in position and protected from damage.
- Inspect all temporary generator installations. Immediately remove from service any installation that does not comply with AS/NZS 3000 and AS/NZS 3010.
- Ensure all circuit protection devices are tested and verified to operate effectively. Ensure ongoing inspection and testing is conducted to ensure the continued effectiveness of circuit protection devices, and the safe condition of wiring.
- Ensure that temporary generators are maintained in accordance with the requirements of the OEM recommendations and relevant Regulations and Standards.
