INCIDENT ALERT

LOCATION:	CONSTRUCTION/DELIVERY SITE	ALERT STATUS:	Normal
ACTIVITY:	LIFTING	DATE ISSUED:	06/07/2021 00:38:00
SUB ACTIVITY:	NO SUB ACTIVITY AVAILABLE	INCIDENT No:	03594

Fatal 5 - Two incidents involving the delivery of concrete

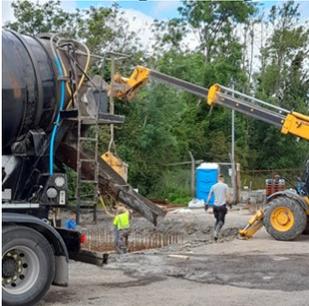
Incident 1

A mixer driver filled a concrete skip on a customer's site. A construction site operative attached a metal lifting chain to the concrete skip and then directed a plant operative to lift it with a loadall. When the skip was at a height of approx. 2m, the lifting chain snapped and the skip fell. It landed at the rear passenger side of the lorry. Fortunately, the driver had stepped away from the lifting zone. This had the potential to be very serious. The driver noted that after the incident the site personnel then lifted the skip with a worn webbed sling.

1. There was no lift plan in place - the correct lifting accessory (chain or sling) to lift the concrete skip was not planned in advance.
2. Construction site personnel did not use a lifting chain that could lift this skip safely – they may not have known the weight of the filled skip and so used a lifting chain that was not strong enough or they may not have known or understood the rating of the chain
3. The lifting chain may already have been damaged.

- Drivers must stop to assess every delivery site – if it is not safe to deliver contact your line manager or use your STOP WORK card.
- Head to toe high visibility clothing, metatarsal safety boots, hard hats, safety glasses and gloves must be worn when outside the cab.
- Always look for overhead hazards whilst on sites – this includes objects falling from scaffolding, items being lifted by plant or cranes and overhead lines. Hard hats must be worn at all times.
- Drivers and all site personnel must move to a safe area well outside the lifting zone when concrete skips and any other items are being lifted overhead.
- Drivers must not handle concrete skips. It is the responsibility of the customer to safely dispose of any unused material in concrete skips – it must not be returned to the drum of the mixer lorry.
