WPHS Qld alert

Palfinger stabiliser locking system

Issued: 17/05/2021

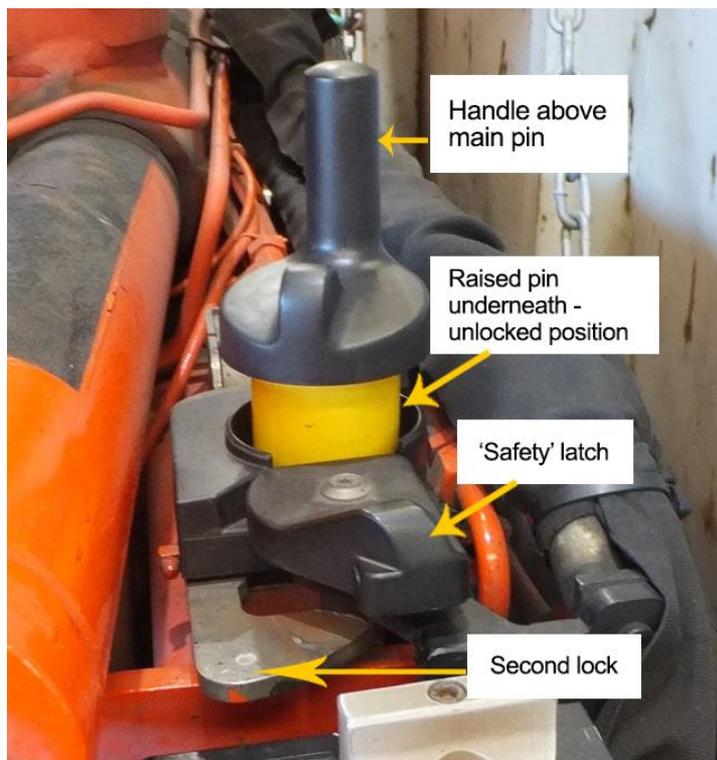
The VLC was fitted with the Palfinger double locking system that includes a main locking pin and a second lock, which is similar to that provided on some contemporary Palfinger cranes. Both locking systems are activated through a handle above the main pin. The handle is rotated to disengage the locking system prior to the

stabiliser being manually extended (refer Photograph 1). When the stabiliser is fully extended, the main locking pin drops into position to lock the stabiliser in place. To pack the stabiliser away, the handle needs to be rotated to lift the locking pin out of the locked position before the stabiliser can be pushed in. Once the stabiliser is manually retracted, the main pin drops back into the locked position and the second lock engages. A plastic 'safety' latch then needs to be manually moved to the locked position (refer Photograph 2).

Photograph 1: Plastic latch un-locked and pin applicator rotated. Stabiliser ready to be extended.

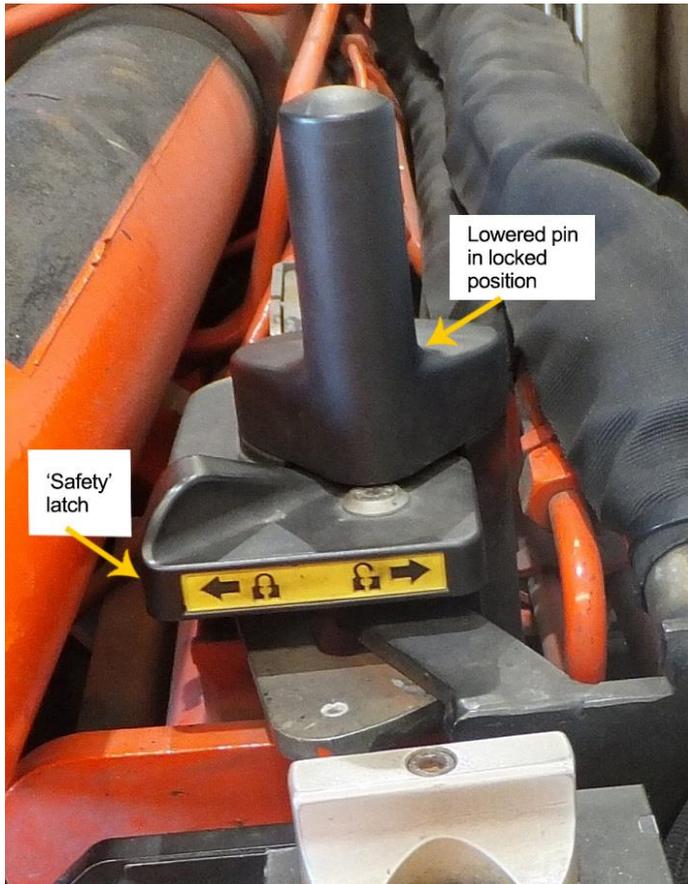
Photograph 2: Main pin, secondary steel latch and plastic latch in locked position with stabiliser stowed.

A spring incorporated into the design of this latch helps prevent the latch from being closed unless the stabiliser is in the transport position. However, it appears that it is possible to inadvertently overcome the spring force and close the safety latch while the stabiliser is locked in the extended position.

Provide workers with additional training to re-enforce the need to follow the Palfinger operating instructions so that the safety latch¹ is not engaged when the stabiliser is in the extended position.

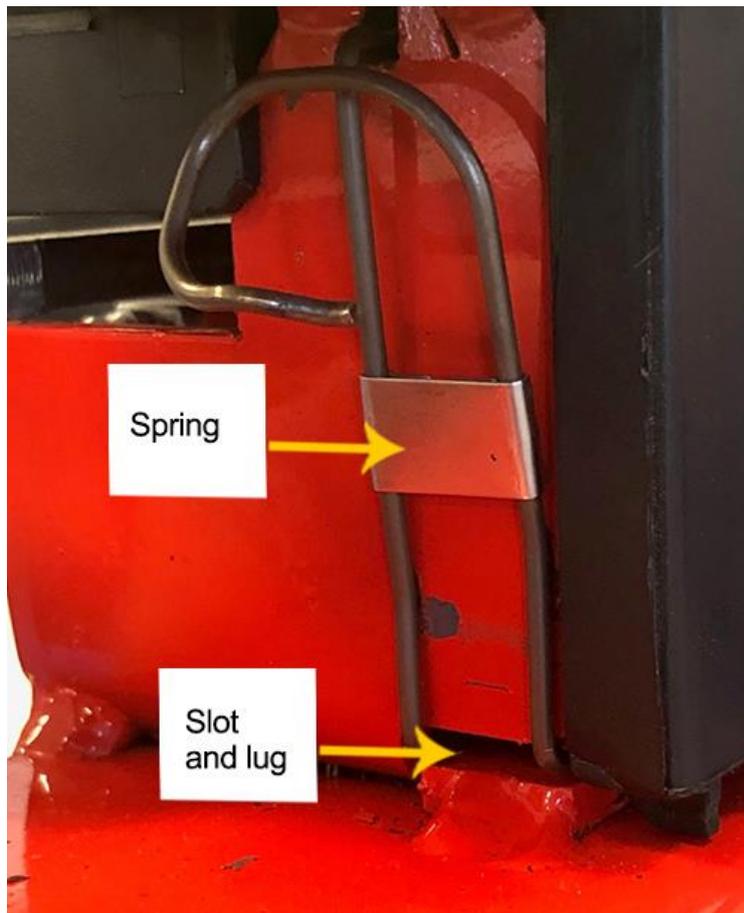
In addition to the above, on older models where a spring is not provided on the safety latch, the latch can be easily closed when the stabiliser is fully extended as there is no spring tension to resist this action. Although the proximity switch can be retrofitted to some older Palfinger models, the spring cannot always be retrofitted. This is due to the design of the area where the spring is fitted being changed (refer Photographs 3 and 4).

Photograph 3: Newer design with slot and lug to allow spring to be fitted to safety latch.

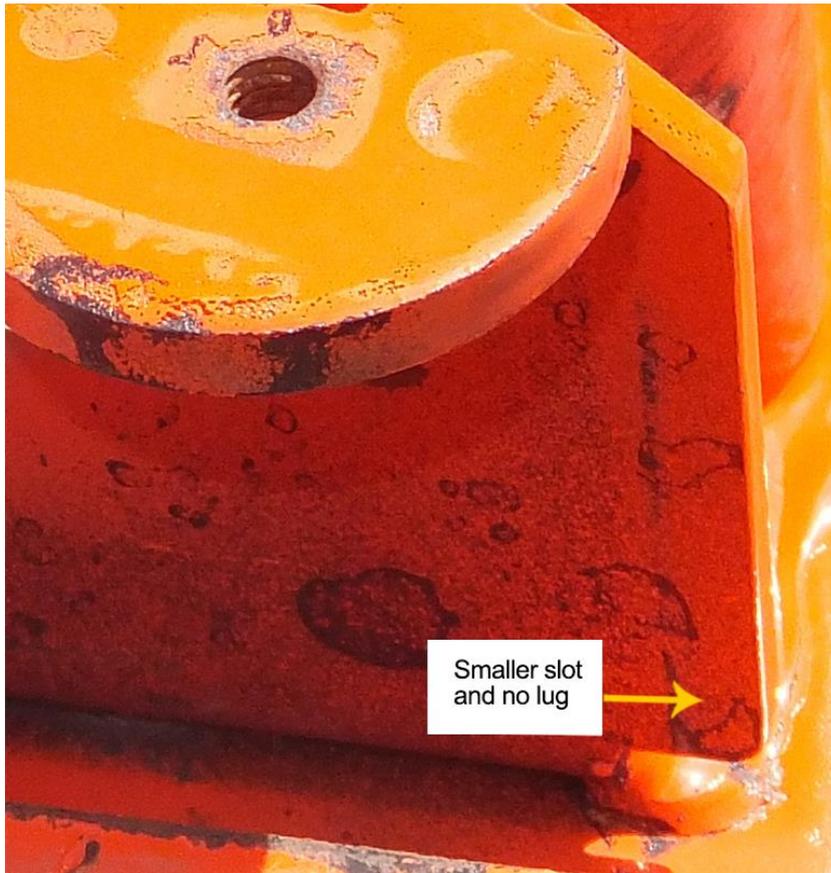
Photograph 4: Older design showing similar location to Photograph 3 (parts removed for clarity) – spring cannot be fitted without significant modification.

On cranes where the spring is unable to be fitted due to the crane design, Palfinger Australia should be approached for advice¹.

As an alternative, fit a stabiliser warning device, that detects the stabiliser in the locked position for transport and warns the driver in the truck cabin if this is not the case.
