# SAFETY ALERT

**DATE: JUNE 2021**

## Potential crush point on personnel transport vehicle

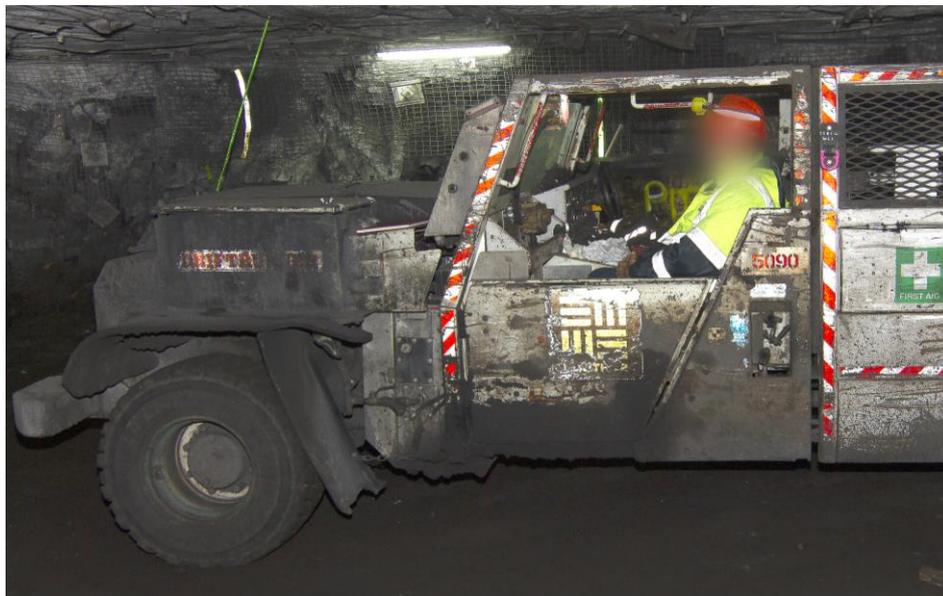
As the vehicle turned into the cut-through, the passenger was adjusting his position in his seat. The worker leant his forearm on the door sill to lift himself vertically. The passenger did not see the stowed equipment.

The driver noticed there was limited clearance and coasted past the piece of equipment. As the vehicle passed the stowed equipment, the driver reported hearing the passenger scream. The driver stopped the vehicle and ran around to the passenger's side to determine what had happened and observed the passenger had suffered serious injuries.

Figure 1: A re-enactment involving a personnel transport vehicle

- Review the design of passenger compartments to ensure the design does not facilitate or promote workers from resting their limbs in potential crush points. Communicate any necessary changes with equipment owners.

- Review passenger compartments to identify any potential crush points and put controls in place to protect workers.

- Review passenger compartments to identify any potential crush points and put controls in place to protect workers.
- Communicate this incident with mine workers.

- Ensure effective training and supervision is in place to prevent workers resting their arms on the door frame of underground transports.

- Do not place limbs outside of the vehicle or rest your arms on the door sill of mobile plant, even if it is only momentarily.
