HSEQ ALERT

Type:	Health <input type="checkbox"/>	Safety <input checked="" type="checkbox"/>	Environment <input type="checkbox"/>	Quality <input type="checkbox"/>
Title:	PLANT DAMAGE – 6.5T HITACHI EXCAVATOR TIP-OVER			
Date:	27 th of January 2021	Alert No:	003- 2021

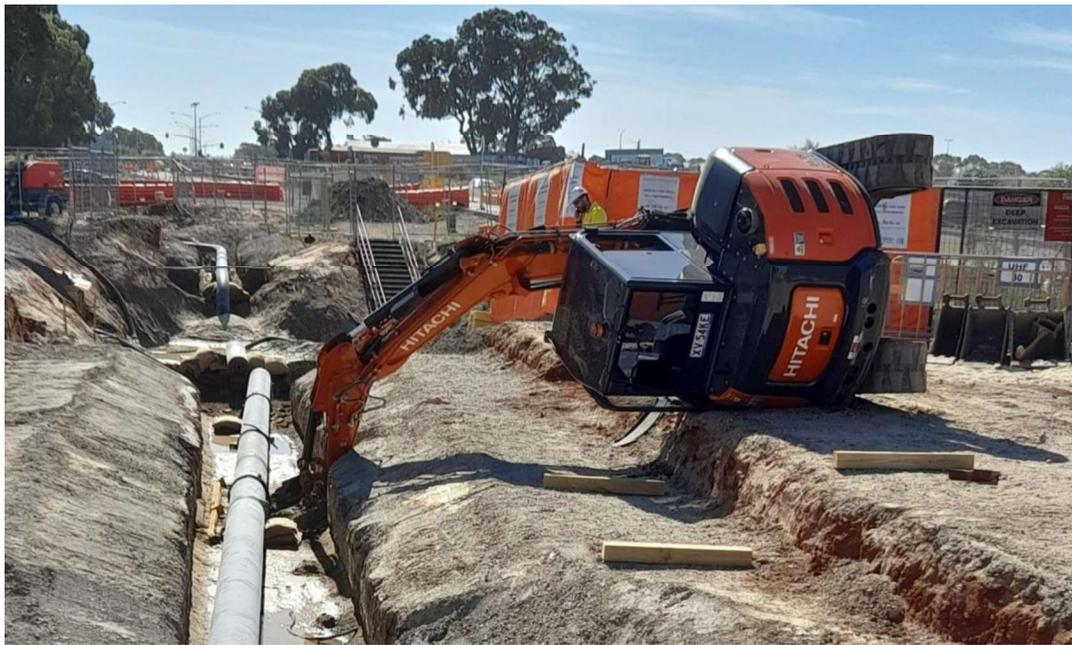
Photographs:

On the 27th of January at approximately 12:30hrs, an incident occurred along Centre Dandenong Road whilst a Service Authority subcontractor's 6.5t Hitachi Excavator was undertaking lifting operations to install a 300mm x 22m main gas pipe.

Prior to the incident occurring, the Operator was tracking parallel to the excavation (approximately 1.2m in depth) with a 22m length of pipe with an approximate weight of 1100kg. The lift involved landing the pipe on a battered edge within the excavation prior to moving the excavator into a front facing position for the final lift into the bottom of the excavation. The load was rigged by a licensed dogman who had used rated chains connected to a spreader bar and two rated soft slings.

The excavator Operator attempted to land the pipe on preplaced dunnage located along the battered edge within the excavation when the excavator has tipped onto its side whilst lowering and placing the load.

Lifting of load approximately 200% (1100kgs) higher than the Rated Lifting Capacity (SWL Static 640kgs / Dynamic 560kgs) of the Hitachi ZX65USB-5A 6.5t Excavator.

- Subcontractor stood down pending the outcome of the investigation
- MCDDJV Full Site Review of Earthmoving Equipment used as a crane
- Project wide communication shared across every site prestart to communicate the conditions of using an excavator for lifting – Rated Capacity

- All projects review incoming plant procedures to ensure all earthmoving equipment that is intended to be used for lifting operations (i.e. used as a crane), complies with the requirements of the Crane and Lifting Safe Operating Procedure MMS # HSEQ-HS-SOP001-GEN-ALL Sections 6 and 8
