NZ Safety Alert

20 March 2020

Loader bucket hits truck

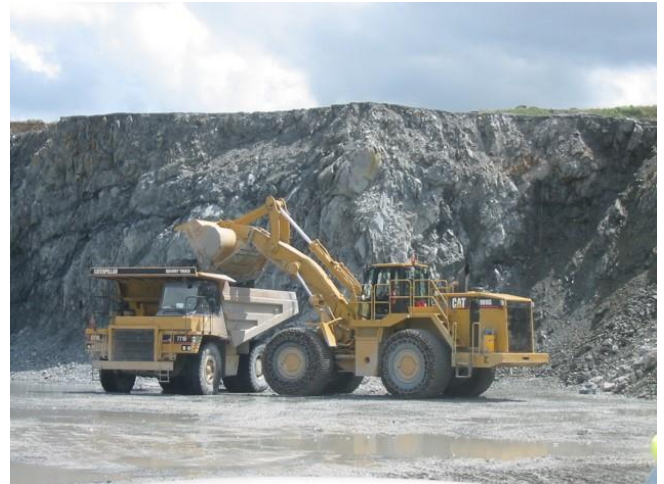
A front-end loader with loaded bucket, moved forward with its bucket raised in preparation of loading the next dump truck. As it did so, it collided with the dump truck that was moving in to be loaded – causing damage to the cab, handrails and platform. The operator of the dump truck was not injured in the collision.

1. Controls for managing traffic in working areas is effective in ensuring workers are not exposed to risk of vehicle collision.
2. There is clear communication and visibility between loaders and trucks in working areas.
3. Loaders do not tram material with the bucket raised to a point that it obscures visibility.
4. Operators of mobile equipment are trained and assessed as competent to safely operate all equipment.
