## Failure of a road tanker pressure/vacuum relief valve

### Health and Safety Executive - Safety alert

CEMHD2 – 2020

01 March 2021

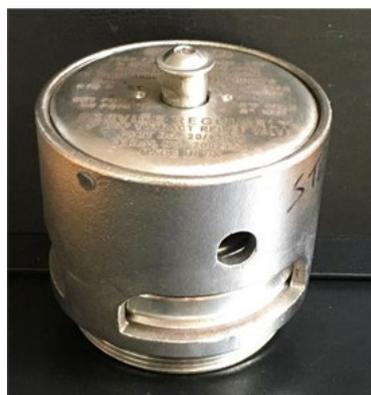
Figure 1

**Figure 1** A new 2.5-inch combined pressure/vacuum relief valve

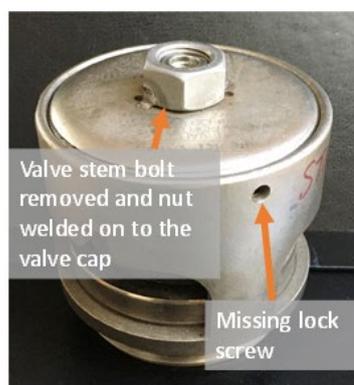
Figure 2

**Figure 2** The same type of valve with an unauthorised modification and the locking grub screw missing.

The welded nut prevented the free movement of the valve stem and resulted in the valve sticking in an open position. In this incident, the correct action by the vehicle driver minimised the release of hazardous vapour and prevented any harm to people or damage to property.

During what should have been a momentary operation to vent the road tanker, the vacuum relief element of the valve became stuck in an open position allowing an uncontrolled escape of hazardous vapour. The relief valve fitted to the tanker barrel had been modified in a way that made it unsafe. The flanged bolt on the end of the valve stem had been removed and a nut had been welded to the valve cap. The end of the valve stem was able to catch on the thread inside the nut, preventing the vacuum relief element of the valve from closing.

- The removal of the vacuum valve stem top bolt could allow the valve to open so far that the stem fouls on the valve cap itself, this will also prevent the valve from closing
- The locking screw in the side of the valve body had not been replaced after the valve was reassembled after servicing. This locking screw prevents the valve cap rotating, which will change the pressure retaining capability of the valve
- The valve was being serviced less frequently than suggested by the manufacturer
- The valves vacuum protection function was not being routinely tested before refitting

Users should visually inspect the pressure/vacuum relief valves fitted to tank containers and road tankers. The inspection should establish if there have been any unauthorised modifications made to the valve, particularly items added to the valve to allow for easier dismantling.

Anyone working on relief valves should be competent to do so. Valves should be serviced following the valve manufacturer's guidance. Valves should not have temporary nor permanent modifications in order to by-pass the need for special tools to carry out the work. Where a modification is felt necessary, the valve manufacturer or similar competent person should be consulted.
