# WEEKLY INCIDENT SUMMARY

Week ending Friday 6 December 2019

This incident summary provides information on reportable incidents and safety advice for the NSW mining industry. To report an incident to the NSW Resources Regulator: phone 1300 814 609 24 hours a day, 7 days a week.

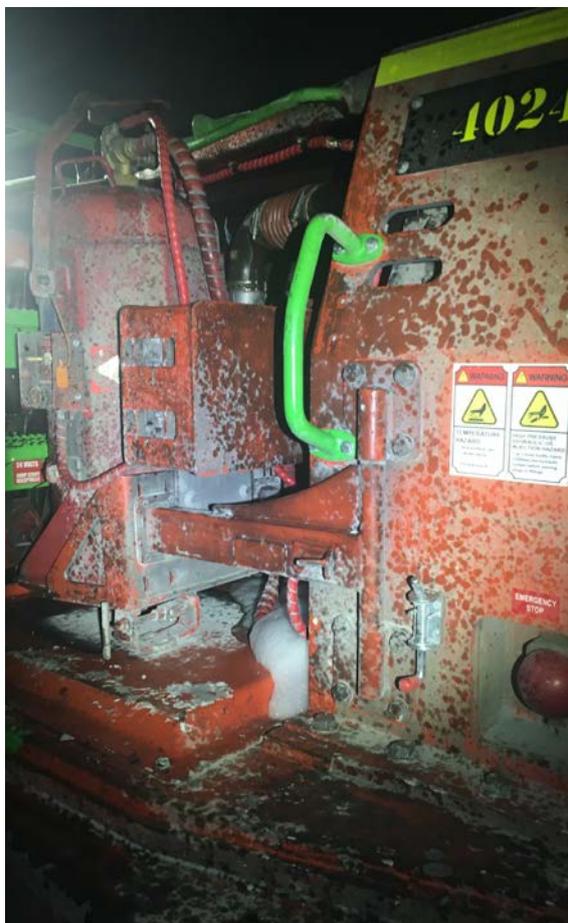
INCIDENT TYPE	SUMMARY	RECOMMENDATIONS TO INDUSTRY
Dangerous incident IncNot0036181	A fire occurred on an underground load haul dump machine (LHD). The fire suppression system was activated, and the flames were extinguished. Three workers retreated to a refuge chamber as a precaution.	<p>When completing emergency exercise planning, mine operators must consider fires on mobile equipment.</p> <p>Fires in underground mines are a significant risk to all workers. The likely position of fires (especially in declines) must be determined and appropriate emergency equipment must be installed in accessible locations including refuge chambers, escapeways, first response and rescue equipment.</p>

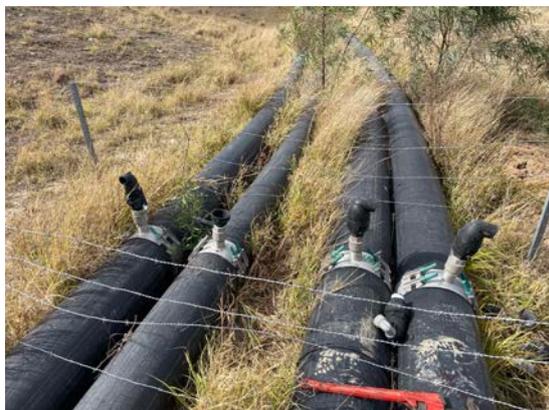
**Dangerous incident**  
IncNot0036193

A contractor suffered a laceration to the mouth, one broken tooth and loose teeth after being hit by parts of a breather. The worker had isolated and changed a breather on a large water pipeline. Upon removing the isolation to the breather, a mechanical failure occurred resulting in the worker being hit.

Mine operators should review how workers and supervisors are trained to recognise the potential hazards associated with all energy sources. When re-energising equipment after repairs and maintenance, operators must consider the potential for premature failure and remove themselves from the line of fire.

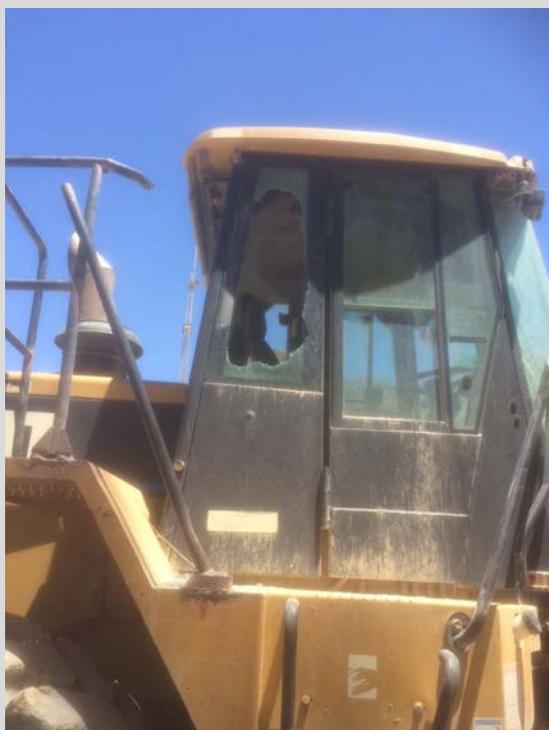
**Dangerous incident**  
IncNot0036207

A blast was conducted on the floor of a quarry to break up some large rocks. Eight shots were fired at the same time. There was a loader parked up and unoccupied about 200 metres from the blast (in front of the blast). The nearside window of the loader was broken by flyrock from the blast. On further investigation it was found that workers were positioned within the 400 metre exclusion zone, however they were not affected by flyrock. No flyrock fell outside the exclusion zone.

Mine operators are reminded that appropriate systems must be in place to review and audit the explosives control plan and blasting work practices to ensure that exclusion zone requirements are adequate and adhered to. See our publications:

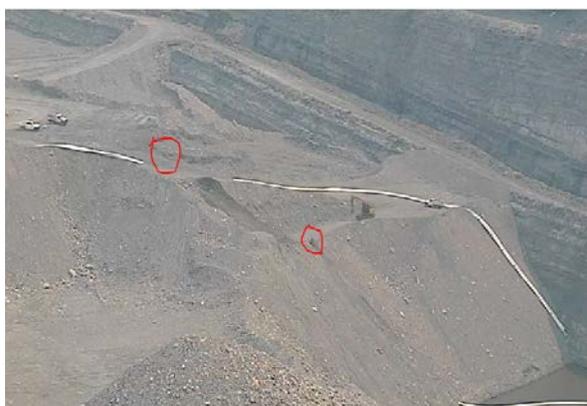
Dangerous incident  
IncNot0036218

A bundle of four polypipes (320 millimetres in diameter and 120 metres long) were being maneuvered by contractors using a wheeled excavator when they lost control. The pipe bundle slid down a batter and over a catch bench where two workers were standing, then continued down a steeper batter to the bottom of the open cut workings, landing in 5-metre deep water. It was estimated that the pipes missed hitting the workers by about 5 metres.

Mine operators need to ensure that adequate measures, including fit-for-purpose equipment, are in place to prevent unplanned movement of pipes in such circumstances.

Safe standing zones are a known control for keeping people out of the line of fire. All potential failures must be identified when determining safe standing zones before starting work. If the task or environment changes, workers must be reminded to stop, reassess the implemented controls and identify any new controls that must be used.

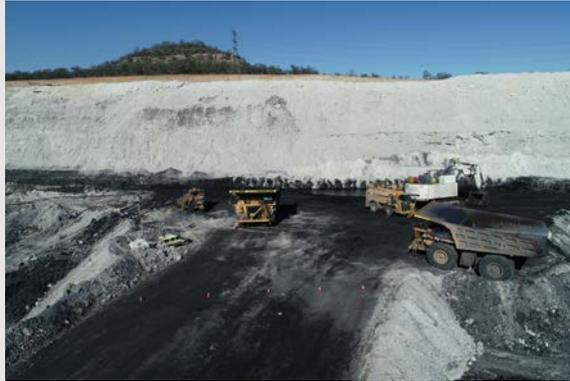
Dangerous incident  
IncNot0036219

A heavy vehicle operator was parking a truck in a park-up area. In reversing the

truck into position, the operator reversed into a light vehicle that was not fully parked in the designated area. There was no-one in the vehicle at the time, and it was significantly damaged. The park-up bay was congested with several heavy vehicles.

When parking up light vehicles in designated areas, vehicles should

be parked fully within the designated area. If there is inadequate room for the vehicle then it should either be parked in another area, or adequate demarcation put around the vehicle so that it is identifiable to all other road users including heavy vehicle operators. Heavy vehicle and light vehicle park-up areas should be segregated appropriately.
