# WEEKLY INCIDENT SUMMARY

Week ending Friday 3 January 2020

This incident summary provides information on reportable incidents and safety advice for the NSW mining industry. To report an incident to the NSW Resources Regulator: phone 1300 814 609 24 hours a day, 7 days a week.

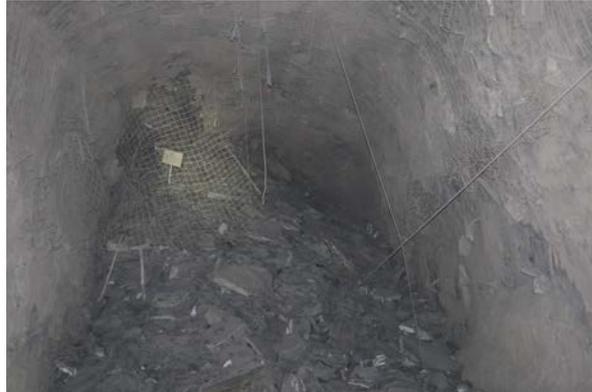
INCIDENT TYPE	SUMMARY	RECOMMENDATIONS TO INDUSTRY
Dangerous incident IncNot0036395	<p>A metalliferous mine was recovering a buried load haul dump machine (LHD) from a stope using a second LHD under tele-remote control when a fall of ground occurred in the recovery drive that resulted in the recovery LHD being buried. The fall of supported ground was about 2000 tonnes of material.</p> <p>No workers were in the vicinity when the fall occurred.</p> <p>Investigations at the time of writing suggest the fall may have been related to shotfiring, which occurred about two hours earlier in a stope two levels below where the fall occurred.</p>	<p>When undertaking change management relating to an alteration in mining process or sequencing, mine operators should complete a full geological assessment to determine whether the proposed change increases the level of risk, or introduces new risks.</p>

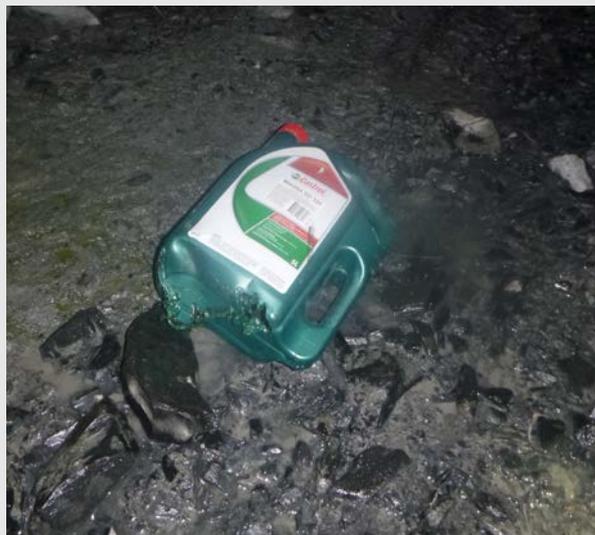
Dangerous incident  
IncNot0036385

At an underground metalliferous mine, a Jumbo operator saw smoke while traversing the decline, but was unable to identify the cause. The operator initiated emergency procedures and the area was evacuated. Workers went to refuge chambers in accordance with procedures.

All workers were accounted for within the refuge chambers. The mines rescue team was deployed to access the Jumbo and found that a lubrication fluid container that had been stored on the machine had melted, which was the causing the smoke.

If it is essential to store containers of combustible fluids on mobile equipment, this should be in a location where they are adequately secured, not subject to excess heat, and there is no possibility of either the containers or leaking fluid making contact with hot surfaces.

Plastic containers should be avoided wherever possible.

At the completion of maintenance activities, equipment should always be thoroughly inspected to ensure all excess material has been removed including combustible materials, cleaning materials, hydrocarbons and tools.

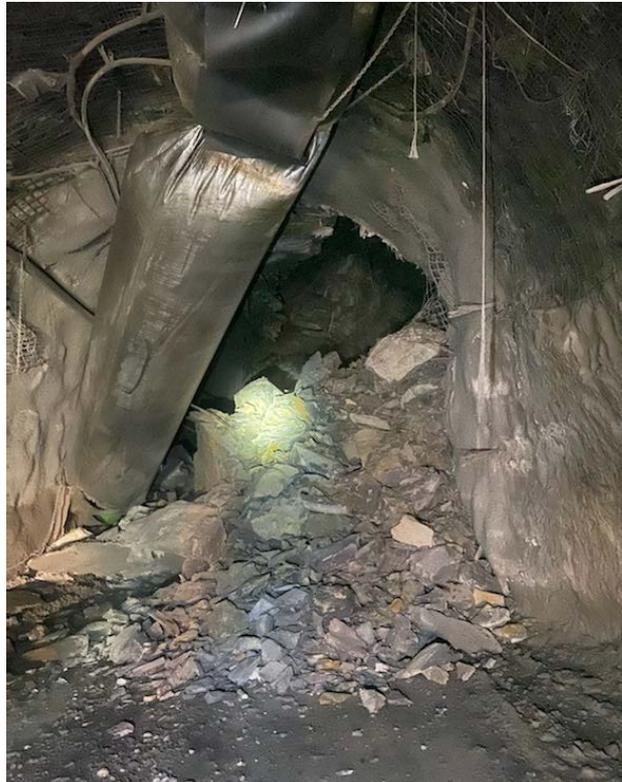
Dangerous incident  
IncNot0036363

A rock fall at an underground metalliferous mine trapped a loader and a light vehicle with a worker inside the vehicle. The worker first heard, then saw the fall of ground about five to 10 metres away. The worker reported the fall and exited the level via the escape ladder

behind where the vehicle was parked. Neither of the machines were damaged.

When developing strata TARPs and support plans, mine operators must consider the predicted stress regime of the surrounding strata through the full lifecycle of a driven roadway.

This incident shows the importance of mine operators establishing and maintaining secondary escapeways.
