Crane Walkway Clip

During a sheet pile installation, a bracket which was holding in place the walkway came loose and fell from the boom landing on the ground next to the crane. The works supervisor heard a noise, as did the controls operator who was working near the crane.

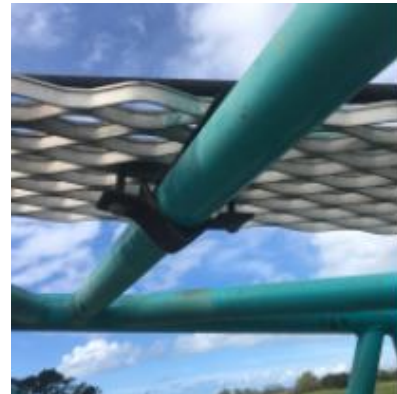
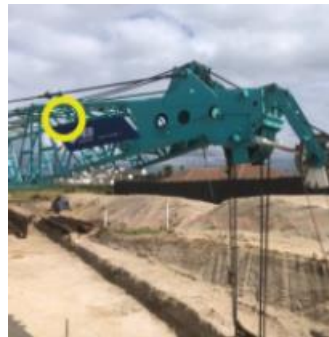
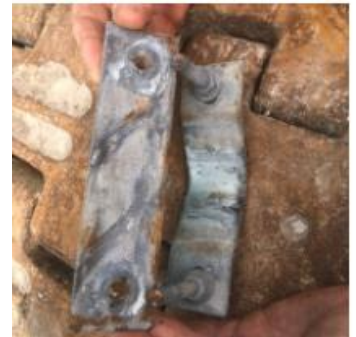
The mechanic inspected the broken bracket as well as all others on the boom and they were all found to be in good serviceable condition.

- The operator is trained, licensed, and competent
- On inspection, it appeared that a tack weld connecting the bolts to a plate had failed, causing the bracket to come loose and fall.
- Exclusion zones were in place

- Exclusions zones are in place for lifting operations
- Identifying the drop zone, providing delineation and ensuring this is communicated to the team during the risk assessment process.
- Weekly inspections with the boom laid down (more often when piling) by the operators of cranes, should include visually inspecting all boom fittings and attachments.

- Monitoring the lift area for unexpected site visitors, members of the public and workers who are unaware of the processes.
- All checks on lifting equipment and inspection regimes
