Mine Incident | Operator's hair ripped out by borer

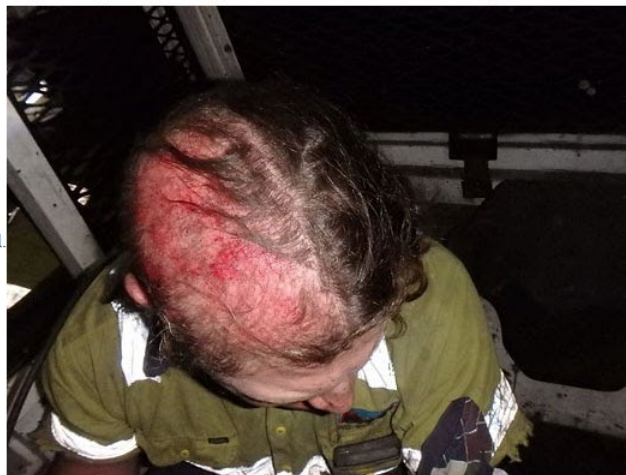
According to a report from the NSW Resources Regulator, a work crew was installing secondary ground support using a handheld boring machine. Two workers were operating the borer. The workers, positioned either side of the machine, were leaning against the borer to apply force. The operator on the left-hand side of the borer lost his footing on wet ground and slipped. This movement caused his hair, which was tied back in a pony-tail, to become

entangled with the rotating drill steel.

Mine operators should review the adequacy of their safety management system with regard to managing the risks of entanglement with machinery. Long hair presents an elevated risk if additional controls are not implemented.

When working with machinery, miners should ensure that any loose fitting items of clothing are secured against their bodies. Hair should be contained (in hair nets or inside helmets) to prevent contact with rotating components.
