Significant Incident Report No. 242

Subject: Tyre fitter's fingers crushed while operating hydraulic bead breaker

Date: 14 June 2016

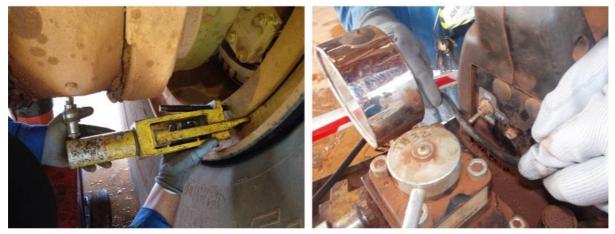
Re-enactments showing approximate hand grip on the bead breaker and position of power cable under the toggle switch

Direct causes

- The hydraulic power pack was energised with the control valve lever in the 'advance' position while the equipment was being positioned for operation.
- The tyre fitter inserted his fingers into the sliding section of the hydraulic bead breaker, exposing them to moving parts when it activated.

Contributory causes

- The equipment design does not encourage the correct positioning of hands nor restrict access to moving parts.
- There is no guarding to prevent inadvertent contact with moving parts nor labelling on the equipment to warn of the nip or crush point.
- Work instructions did not outline the controls for all hazards associated with the task.

- Identify hazards associated with the operation of equipment in conjunction with the recommendations of the original equipment manufacturer (OEM). Assess the risk of workers being exposed to those hazards and implement appropriate controls.
- Document all practical measures to reduce the exposure to an acceptable level in a standard work procedure.
- Confirm that the OEM's instructions for the safe use of equipment are available and followed.
- Assess workers as competent for the task before they operate plant and equipment.
- Ensure hydraulic equipment is not energised while being positioned for the task.
- Identify if more than one person is required to carry out the task safely.
