NNTP SITE SPECIFIC SAFETY ALERT

EXCAVATOR OPERATOR LACERATES LEG ON BLADE

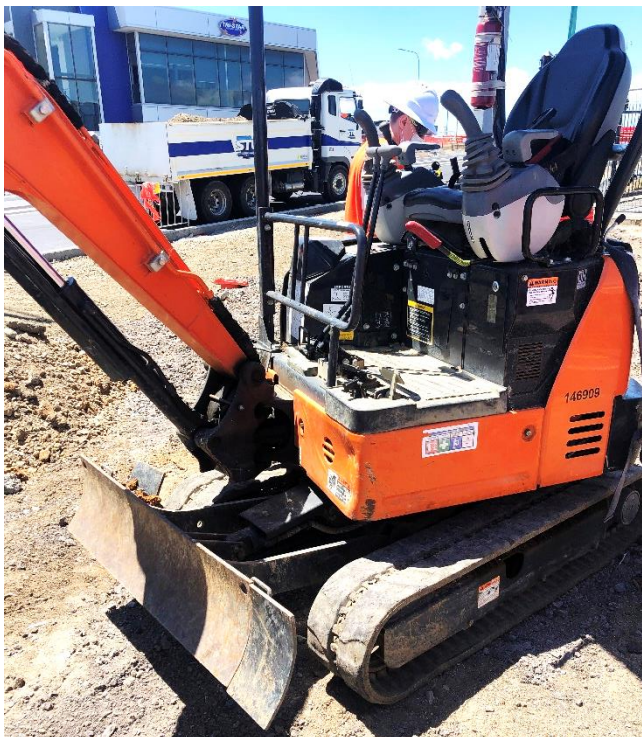
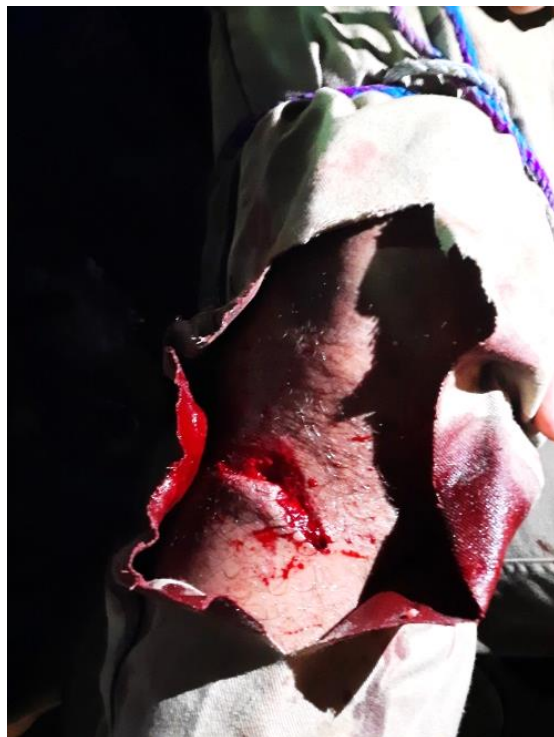
- An operator exited a 1.7 tonne Hitachi excavator with its seat facing a raised stabilising blade as shown in the photograph above.
- As he stepped down his legs entered the space between the blade and the body of the excavator causing him to stumble.
- His right leg was lacerated when it made forceful contact with the stabilizing blade's top edge.
- The laceration required 14 stitches to close it and he needed crutches to assist him to walk.

- The operator did not position the blade behind him to eliminate the blade as a hazard when he got out of the excavator. This was the first poor choice he made.
- His second mistake was not to ground the blade as a safety message displayed on the excavator advised operators to do.

- All plant operators are reminded of the requirement to exit plant with the cab parallel with the tracks with the blade position to the rear and to use the tracks and/or the provided steps to exit safely.
- All plant operators are reminded of the requirement to ensure that when a stabilising blade is present that it must be lowered to the ground prior to exiting the excavator.
