SAFETY ALERT

Safety Alert No. 416 March 11, 2021 Contact: Jason Mathews Phone: (504) 731-1496

Investigation into Grating Failure Fatality Reveals Deficiencies in Hazard Identification and Communication with Barriers and Barricades

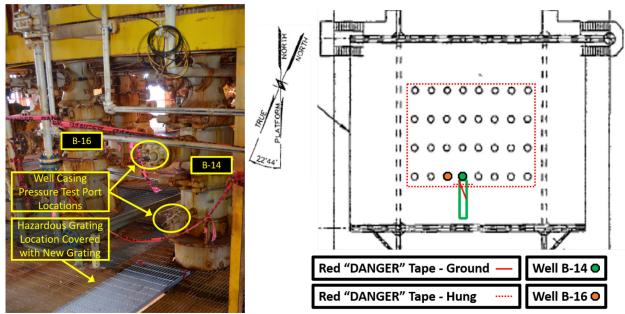
Figure 1: Un-barricaded hazardous grating located within another hazardous work zone regularly accessed by personnel

The investigation showed there was a communication breakdown. Although the hazard of the weak grating had been known by supervisory personnel, a supervisor decided to delay the repair until other work was complete after placing two strands of red danger tape in the area. Supervisory personnel failed to share the information regarding the weak grating with the operators and construction crew.

Additionally, the hazardous grating was not barricaded with a rigid structure. The operating company conflated the definition barricade and barrier to include caution tape and fixed or hard structures. The method chosen did not impede personnel from accessing the hazardous area. Furthermore, the area was saturated with more red

danger tape in close proximity to the hazardous grating for hot work operations on the deck above. Various witnesses reported being in the area of the hazardous grating during the hot work operations and did not notice the red danger tape that was placed to call attention to the hazardous grating.

- Review Safety Alert 353 in conjunction with this Safety Alert.
- Review internal Safe Work Practices and contractor Safe Work Practices and ensure that operations personnel understand the requirements/expectations of barricades. Effective hard barricades include rigid structures that cannot be moved and present an impedance to traversing an area of concern. Operators should reemphasize the need to use hard barricades over caution tape. The tape will not always stop personnel from entering an area with hazards.

- Review bridging agreements at least annually and recognize any gaps in Safe Work Practices between contractor and operator.
- Conduct a review of your facility to identify any open holes or surfaces that are not capable of supporting personnel and, if such an area or open hole is identified, ensure that it has been properly barricaded and/or covered.

- Identify and mitigate additional hazards created from modified work zones during construction and other activities to ensure individuals do not miss or ignore barriers and barricades preventing access to hazardous work areas.

- Review internal Safe Work Practices to ensure that the method to communicate physical hazards and hazards due to ongoing operations are not the same. For example, using red danger tape to mark a location with heavy corrosion while also using red danger tape as area access control for a task.

- Provide signage on barricades to note if fall protection is required before entering and identify the known hazard(s).
