Incident Information Release

SAFEWORK NSW

Woodchipper incident

23 August 2021

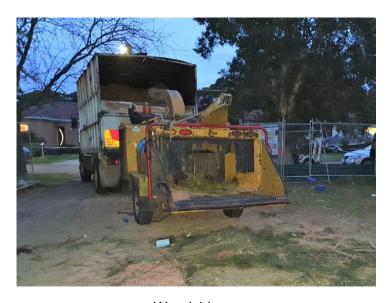
Woodchipper

A 28-year-old worker suffered serious leg injuries while feeding tree branches into a woodchipper. A rope attached to the branches became caught in the blades and wrapped around the worker's legs pulling him into the woodchipper.

- do pre-start checks to make sure everything works properly, including emergency stops and control bar
- operate according to manufacturer's instructions

- establish and enforce exclusion zones around the woodchipper
- make sure there are always at least two competent workers who have specific training on the machine being used
- make sure it's never left unattended while operating

- make sure nothing is entangled in material before it's fed into the woodchipper
- · keep unnecessary ropes away from the work area

- ensure the work area is kept clear for workers to stand and identify any hazards
- feed branches off the centre line the operator feeding the branches into the woodchipper should do so from the side
- use a 'push-stick' at least 1.5 metres long to feed shorter material into the machine
- stop the feed mechanism before reaching into the chute
