NZ Safety Alert

18 February 2022

Uncontrolled movement of dozer

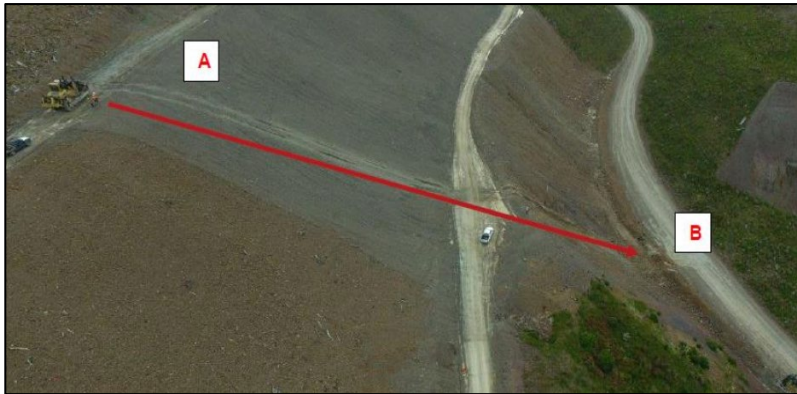
A. Approximate location mechanic exited the dozer.

B. Final stopping point of dozer.

A mechanic was returning a dozer to the workshop along a sloping haul road. While shifting from reverse to first gear, the first gear would not engage, and the dozer started rolling backwards.

As the dozer gathered backward momentum, the mechanic evacuated the dozer by jumping from the cabin to the ground approximately 10 metres from the top of the slope. The dozer continued to travel approximately another 140 metres before stopping on the roadway below.

The mechanic sustained no injuries while exiting the cabin and the dozer had minor damage to a window.

1. All maintenance staff are trained and assessed as competent to operate equipment outside of workshops.
2. All workers understand and follow safe work procedures.
3. Workplace inspections include behaviour and task identification to ensure tasks are carried out safely by qualified workers.
