Excavator roll-over

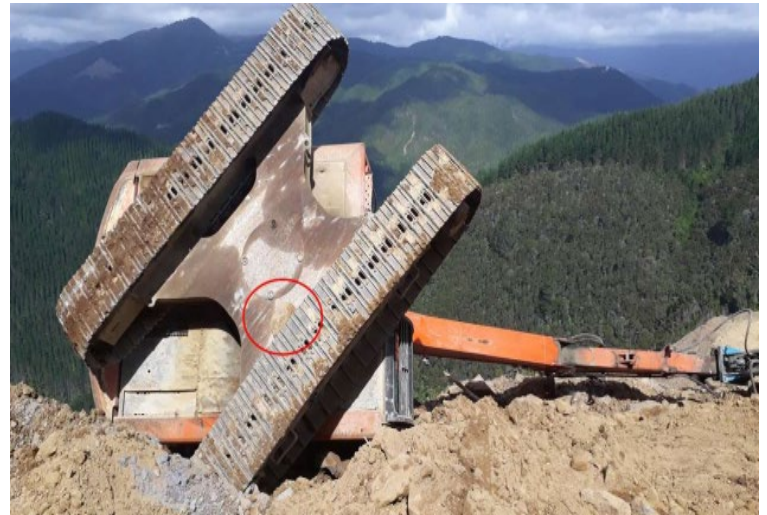
An operator was using a 35t excavator to clear a rock that had become caught in the track of a 20t rock breaker, which he was also operating in an area of hard rock.

The 35t excavator slid sideways off the rib of rock and rolled onto its side.

The operator had been moving between the two machines and was not injured in the incident.

1. Operators moving between machines are familiar with the different track frames and centre of gravity (stability) characteristics of each machine.
2. Excavators are always operated on competent, compacted material and pads are at least 1.5 times the width of the tracks.
3. Operators of mobile equipment are trained and assessed as competent on each piece of equipment.
