NZ Safety Alert

9 September 2022

Failure to follow lockout procedure

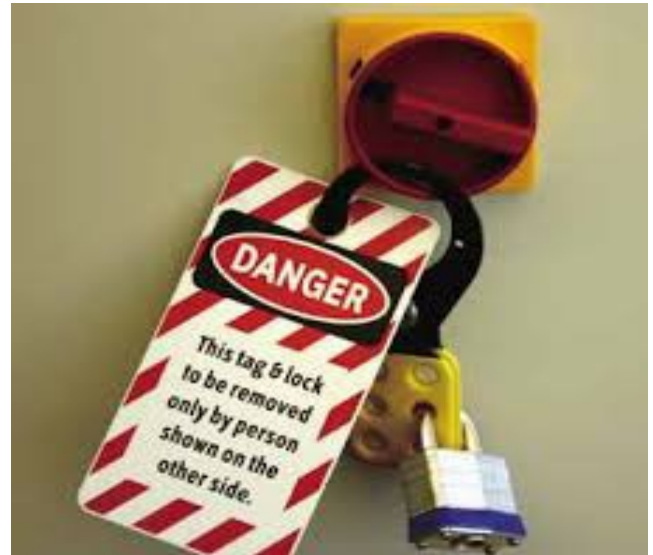
A quarry worker finished clearing spillage from around the primary feeder. The plant operator went to restart the crusher but did not give verbal warning of his intention to start the plant.

As the feeder started some overspill rock fell and could have landed on the other worker, if not for the reaction of a third worker who deflected the overspill rock back onto the feeder.

No workers were injured by spillage rock.

1. All workers are removed from areas of moving plant before starting up after repairs/maintenance.
2. All operators lock out plant prior to working on plant. Isolation points are easily accessible, and that isolating plant is simple for workers to complete.
3. All workers understand and follow isolation procedures, and regular refresher training is carried out.
