NZ Safety Alert

Uncontrolled movement of tip truck

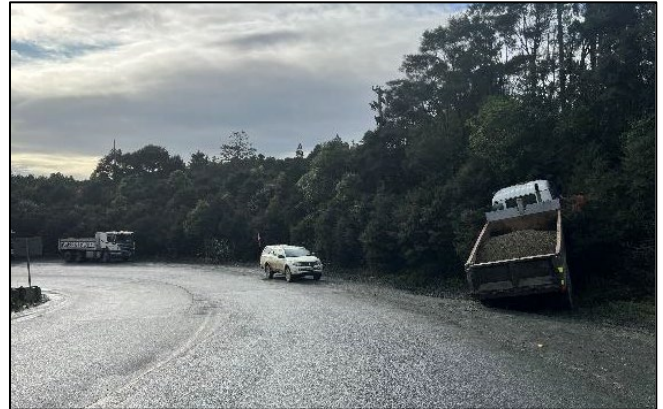
A customer was entering the quarry to pick up a load when he stopped to visit the bathroom. He parked the vehicle on the edge of the haul road, turned it off and pulled up the handbrake.

Upon his return, the vehicle had travelled approximately 75m across the road, and stopped against the bushes on the opposite side of the road.

1. All vehicles are fundamentally stable when parked including bunds, trenches or chocks as additional controls, should the brakes fail.
2. Designated parking areas are available, that restrict the interaction of light vehicles with heavy vehicles on site.
3. All visitors to site are aware of designated parking areas, and requirements to check the stability of the vehicle prior to exiting it.
