NZ Safety Alert

Potential collision avoided

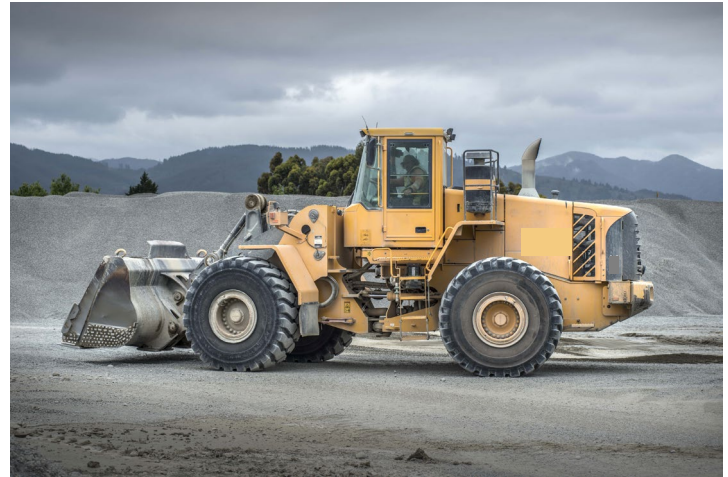
A small truck entered the trailer loading area in a quarry to get a 1t load of material. The truck parked to one side of the road and waited for the loader.

The loader proceeded to get a bucket of material from the stockpile and moved in front of the truck to do so.

As the loader began to reverse the small truck drove directly behind the loader and parked ready for the load.

The loader had to suddenly brake to avoid contact with the small truck.

1. Where practicable, provide designated parking or waiting areas for trucks in loading areas.
2. Two-way communication is maintained at all times when mobile plant is operating in work areas.
3. Mobile plant operators maintain visibility with other vehicles and pedestrians in work areas.
4. Traffic Management Plans are developed and communicated to everyone on site including customers.
