# NZ Safety Alert

8 December 2023

## Potential fall from height

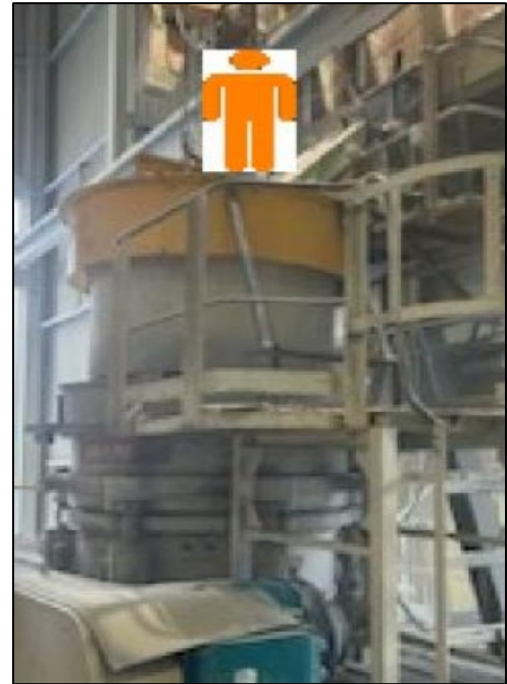
This was not done in time, and another worker was asked to close the feed shutter door. Before the crusher could be shut down, a worker climbed onto the top of the crusher (whilst it was operating) to try and clear the mat which had now blocked the feed chute.

The worker had no fall protection and the grate covering the crusher was not designed to carry the weight of a person.

1. Appropriate controls are in place to protect workers from falls when working at height such as fall barriers, working platforms, harnesses etc.
2. Risk assessments and safe operating procedures identify what controls are to be in place before commencing work at height.
3. Regular workplace inspections are conducted to identify fall hazards including during maintenance.
