NZ Safety Alert

26 May 2023

Working under suspended load

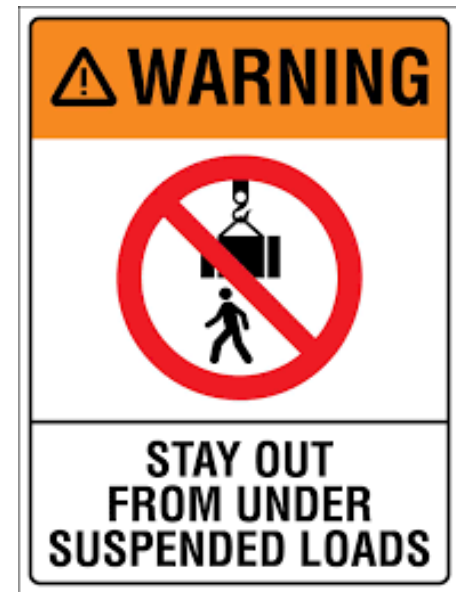
The bin of a dump truck was being replaced in a workshop. The bin was suspended when workers were observed under the bin to pin the rock ejectors and position supporting blocks.

Further investigation also determined that the rigging was incorrectly assembled and that workers had worked at heights without fall protection when accessing the bin to install the rigging.

A working at heights platform for access to such jobs was available but not used.

1. Safe Operating Procedures are continually reviewed and kept up to date.
2. All workers are familiar with SOPs including the appropriate equipment to use for the task.
3. Prestart meetings include any discussion on high-risk tasks to be completed on the shift.
4. Regular workplace inspections are conducted to identify unsafe behaviour and other activities that could put workers at risk of harm.
