NZ Safety Alert

5 April 2024

Worker clearing blockage in crusher

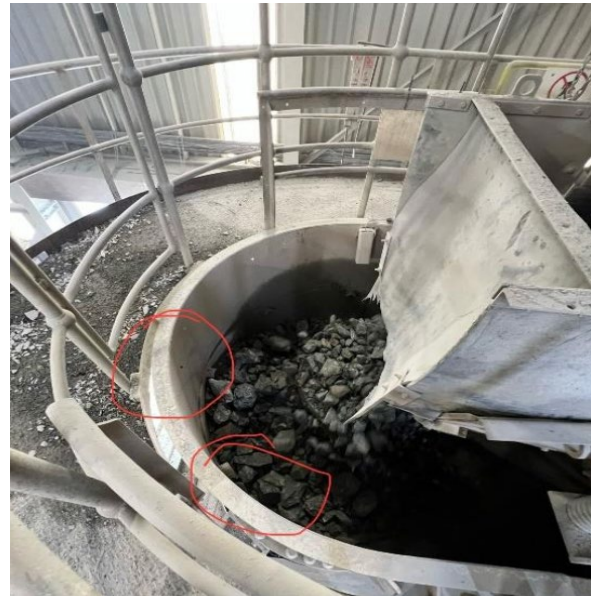
A worker who was on the night shift, was asked by the team lead to clear a blockage in a crusher.

After some time, the team lead went to check on the worker and found him inside of the rails surrounding the crusher, standing on the edge of the crusher, prodding the blockage with a steel bar. The crusher was live at the time.

While no-one was injured, the worker could have fallen into the crusher resulting in very serious, if not fatal injuries.

1. Crushers have guards or barriers that preclude entry while they are operating. Interlocks should ensure the crusher stops if anyone enters past the barrier.
2. All maintenance tasks are risk assessed and appropriate controls put in place prior to commencing the task.
3. Mechanical devices such as rock breakers are used to clear blockages in crushers.
