NZ Safety Alert

December 2019

Truck rollover during tipping

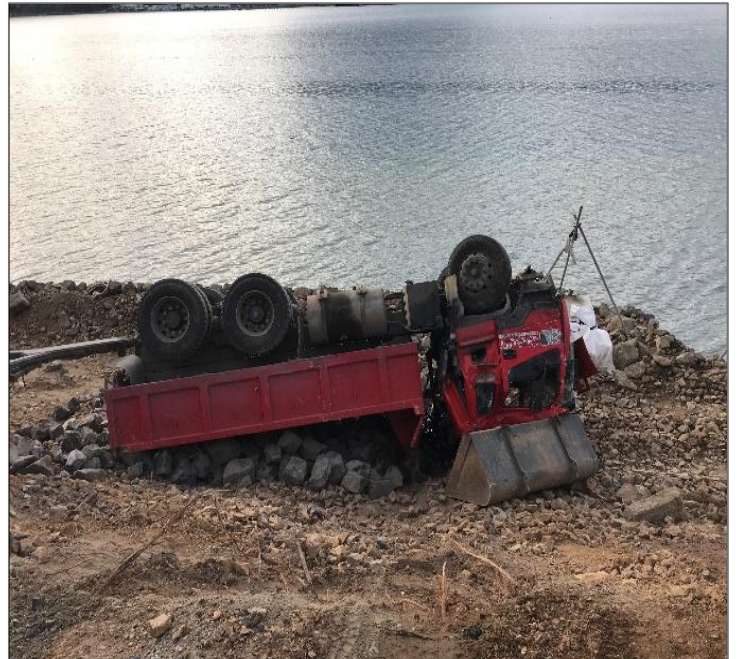
A subcontractor was delivering a truck and trailer load of rock to a site. He tipped the trailer load of rock successfully, then manoeuvred and jack-knifed the trailer to tip the truck at the edge of a drop-off.

He engaged the PTO to lift the truck hoist and at the same time the driver engaged the clutch. As he released the clutch, the truck jerked and jumped backwards resulting in him losing control and traction.

The driver removed his seatbelt and jumped clear. The truck continued backwards, rolling down the face edge and coming to rest on the bench below the road in an upside down position.

It appears that the truck was inadvertently left in reverse gear and there was no exclusion zone at tipping face.

1. When tipping over drop-offs, a stop bund is established at the tip point or the truck tips short and material is pushed over by a loader, dozer or excavator.
2. An exclusion zone is established around tipping areas to reduce exposure to workers from falling plant or material.
3. Tip sites are regularly inspected for edge protection, ground stability, uneven surfaces and other tip hazards.
4. Operators are trained and assessed as competent in safe tipping and managing tip sites.
