Abrasive blasting incident

Explosives safety alert no. 332 | 28 March 2015 | Version 1

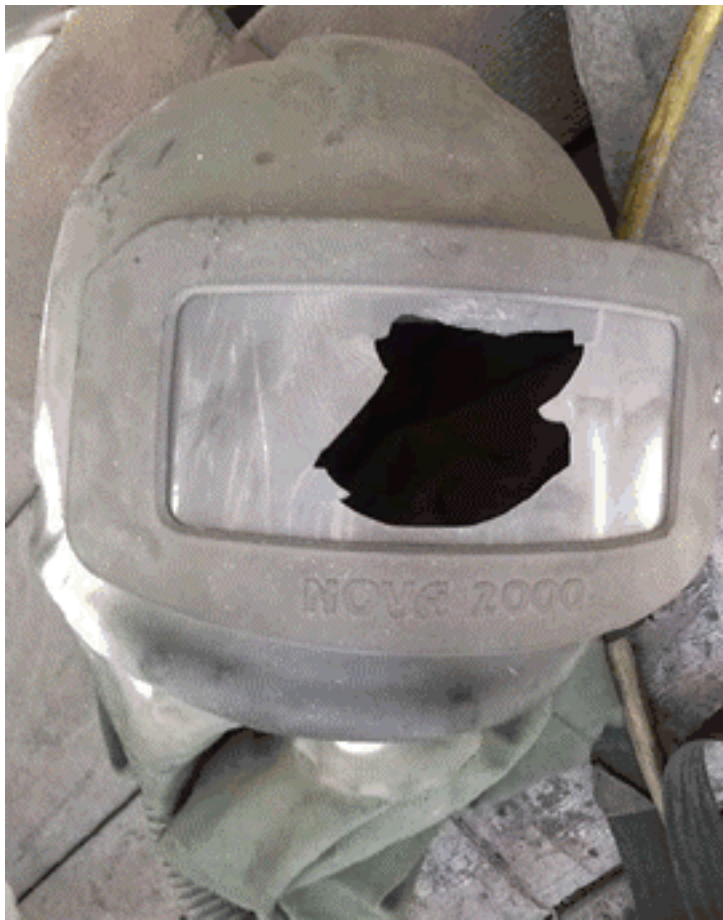
An abrasive blaster and painter was blasting a section of steel structure in a mine preparation plant. He received injuries to his forehead when blast material (garnet) and compressed air penetrated the face shield of his helmet, (see photo).

The person was working in an awkward position due to the shape and layout of the structure being blasted, and at some stage the nozzle was pointed towards the helmet.

It was also found that the PPE, as a last barrier in the hierarchy of controls, was not implemented as per design requirements.

Mines could utilise the Work Health and Safety (Abrasive Blasting) Code of Practice 2015 to assist in developing and implementing abrasive blasting as part of the Safety and Health Management System. The code of practice also includes guidance on PPE use and selection.
