MINE SAFETY INVESTIGATION UNIT

INFORMATION RELEASE

Serious injury

Incident date 1 February 2016
Event Worker seriously injured in fall from articulated dump truck
Location Sibelco Salt Ash Sand Plant, Salt Ash, NSW

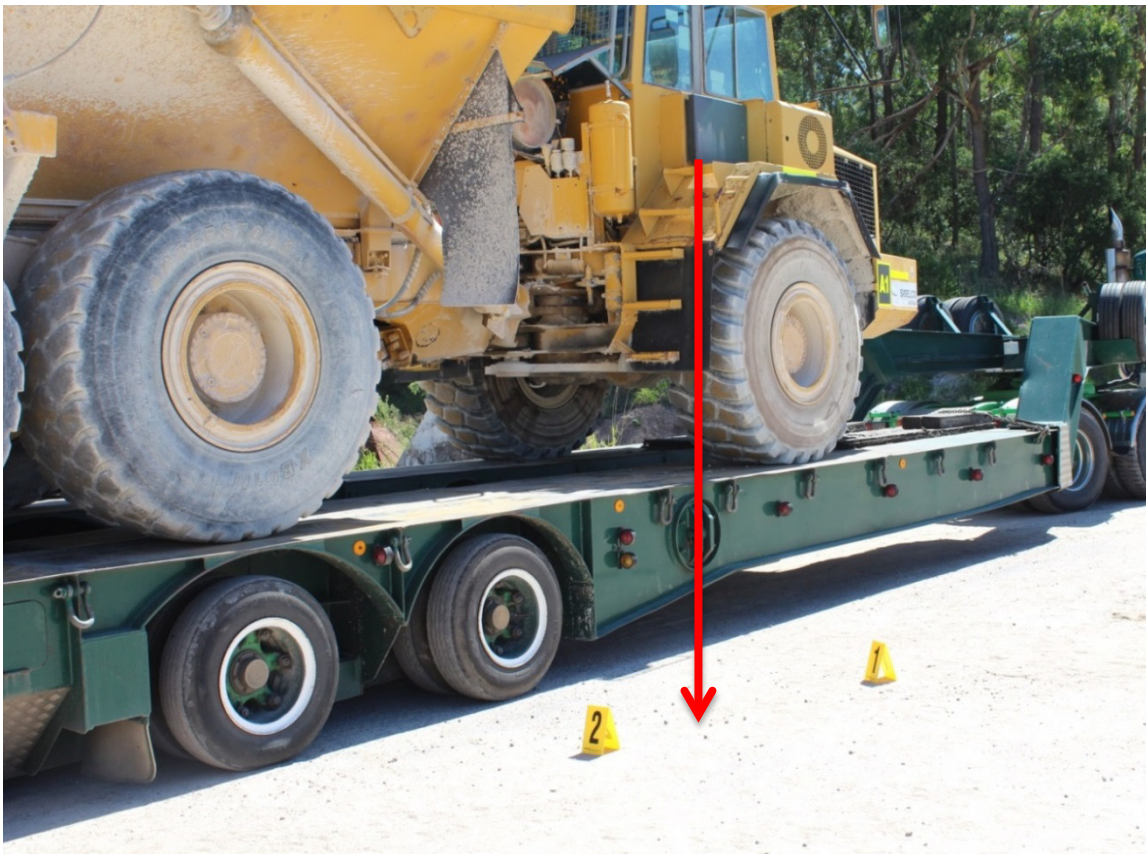
**Photograph of the access ladder provided on the off-side of the Volvo A30 dump truck.
The red arrow indicates the direction of the fall from the front wheel arch.**

The Volvo A30 dump truck had access grab handles for the steps, and handrails for the platform next to the driver's left side entry door of the cabin. The right side did not have a handrail for the platform, although two grab handles had been installed for the right side access steps.

The plant operator appears to have turned to face the rear of the dump truck and walked to the top access step where he has turned his upper body and reached for the grab handle on his right with his left hand. While twisting to reach the grab handle he has fallen to ground level below the low loader.

The height of the dump truck wheel arch platform to ground level is about 1.8 metres. While on the low loader the height was around 2.7 metres.

A person falling from height from mobile plant is a foreseeable risk and adequate measures should be put in place to control the risk. The provision of safe access equipment on mobile plant is a critical control measure to reduce the risk of falling from mobile plant.

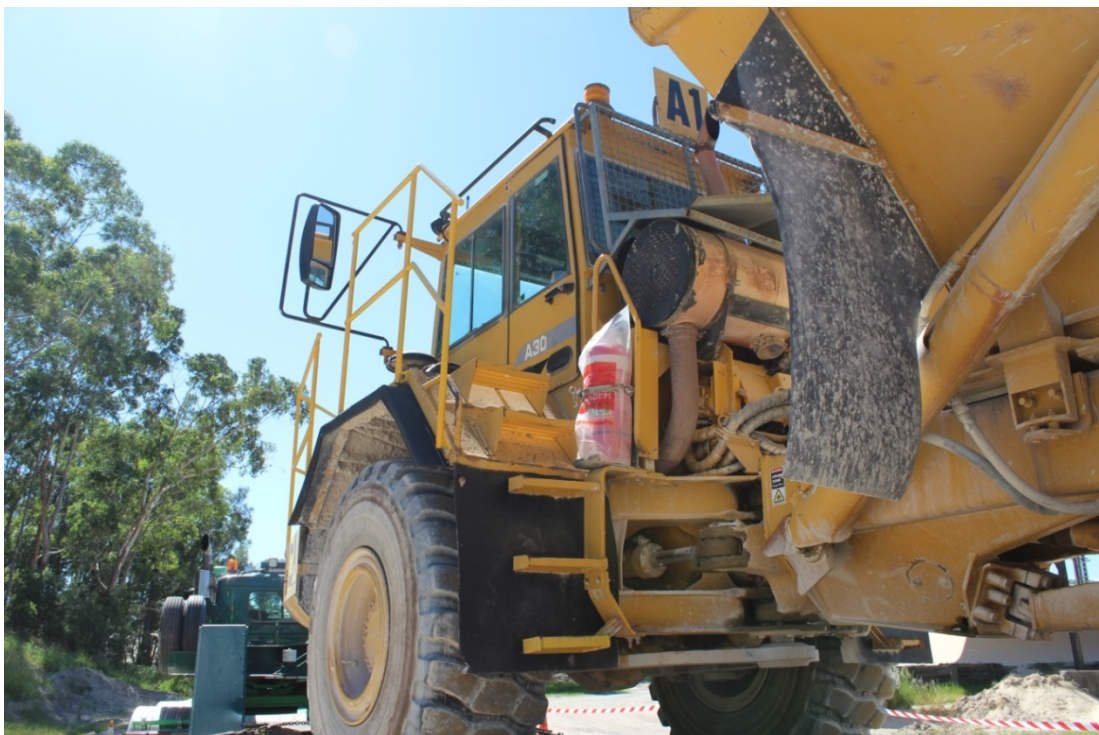
Photograph showing access handrails provided on the driver's entry door side of the Volvo A30 dump truck.
