# WEEKLY INCIDENT SUMMARY

Week ending Friday 2 August 2019

**Mine safety reference** ISR19-30

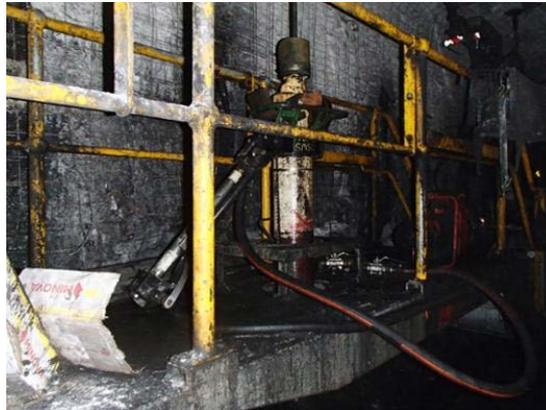
INCIDENT TYPE	SUMMARY	RECOMMENDATIONS TO INDUSTRY
Dangerous incident IncNot0035223	<p>An operator's gloved hand became wrapped around a drill steel, dislocating two fingers. The incident occurred when the worker was in the process of drilling a hole using a hand-bolter on a longwall monorail bolting platform.</p> <p>It was reported that the operator's foot accidentally triggered the rotation of the steel through contact with the bolter trigger, wrapping his hand and glove up in the rotating steel.</p>	<p>Mine operators should review risk assessments and procedures in relation to working in close proximity to rotating components, giving proper consideration to the risk of entanglement from clothing and gloves.</p>
